SEL-21-02

AIR CONDITIONING - TRANSMITTAL OF KELLY AEROSPACE SERVICE BULLETIN KATS-SB-19-001
RUDDER CABLE CLEARANCE ON CESSNA T206H EQUIPPED WITH KELLY AEROSPACE THERMAL
SYSTEMS AIR CONDITIONING PER STC SA03302CH

Rudder cable clearance on Cessna 206H, T206H equipped with Kelly Aerospace Thermal Systems Air Conditioning per STC SA03302CH.

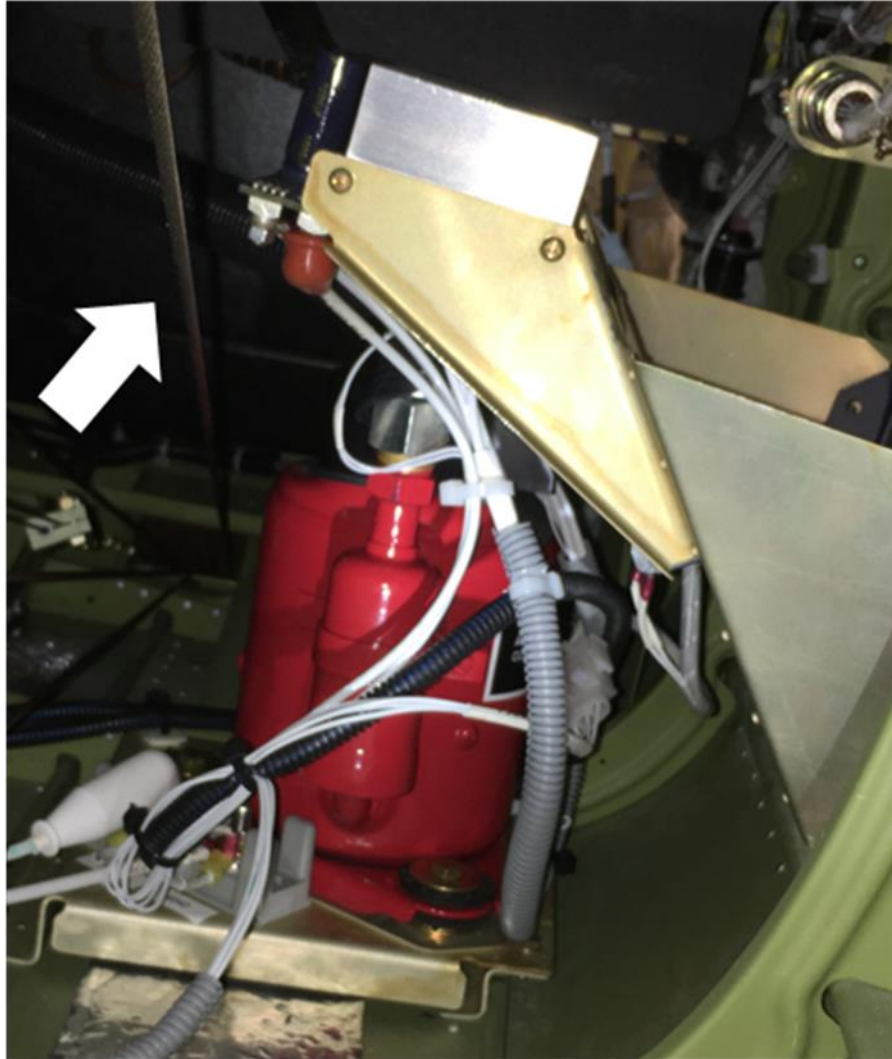
Figure 2
Proper Routing of Rudder Cable
Rudder cable is clear of bracket and circuit board.
AC-01995 cover not shown.

- G. Use a flashlight, or other sufficient light source, and look forward through the access panel opening and make sure the rudder control cable has correct routing and does not touch the AC circuit panel as shown in Figure 1 in KATS-SB-19-001. (Refer to the Kelly Aerospace, Thermal Systems. Service Bulletin KATS-SB-19-001, Dated January 23, 2019 or later.)
