National Transportation Safety Board Aviation Accident Preliminary Report

Location:	Lakeway, TX	Accident Number:	CEN19FA099
Date & Time:	03/14/2019, 1340 CDT	Registration:	N8620B
Aircraft:	Cessna 172	Injuries:	1 Fatal, 1 Serious
Flight Conducted Under:	Part 91: General Aviation - Instructional

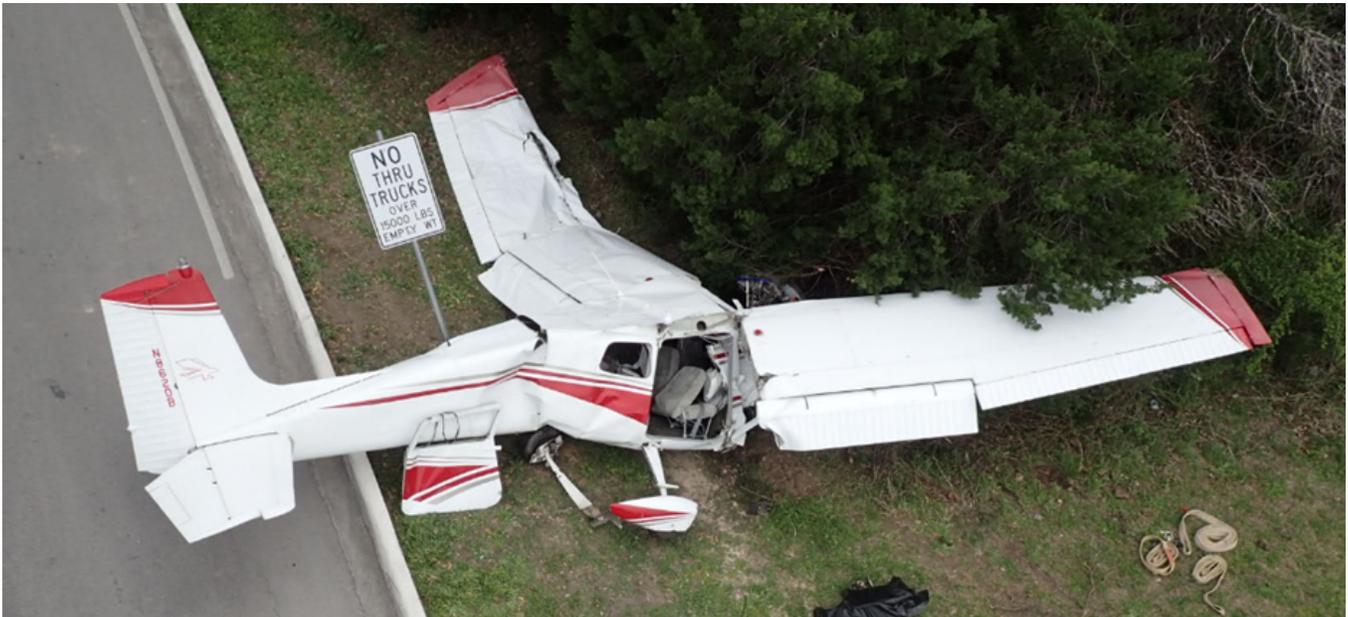
On March 15, 2019, the National Transportation Safety Board (NTSB) investigator-in-charge (IIC), and air safety investigators from Textron Aviation and Continental Motors traveled to the accident site. The team members conducted accident site documentation. The airplane sustained substantial damage to the fuselage, both wings, and the empennage. All structural components of the airplane were located at the accident site. The airplane initially impacted a

tree and road sign to the west of the Lakeway Swim Center on a heading of about 59° prior to the "T" intersection, and various powered propeller impact marks on the asphalt were observed in the direction of travel. The airplane traveled about 180 ft to the northeast across a road before terminating at the final resting point on a heading of about 182°. First responders removed about 25 gallons of fuel from both wing tanks. Just south of the initial impact point and the final resting point is set of power transmission lines that span from the southwest to the northeast, just south of runway 34. No evidence of a power line strike occurring were observed. The wreckage was recovered and transportation to a secure location at 3R9.

Photograph 1 - View of the wreckage (courtesy of the NTSB).
