SERVICE BULLETIN

DATE: October 11, 2018 Service Bulletin No. 634
Engineering Aspects are
FAA Approved

SUBJECT: Cylinder and Head Assembly Serviceable Life

MODELS AFFECTED: All Lycoming Engines with Parallel Valve Cylinder and Head Assemblies (Table 1) shipped from Lycoming Engines between 1-SEP-2013 and 30-APR-2015 (excludes O-235 series)

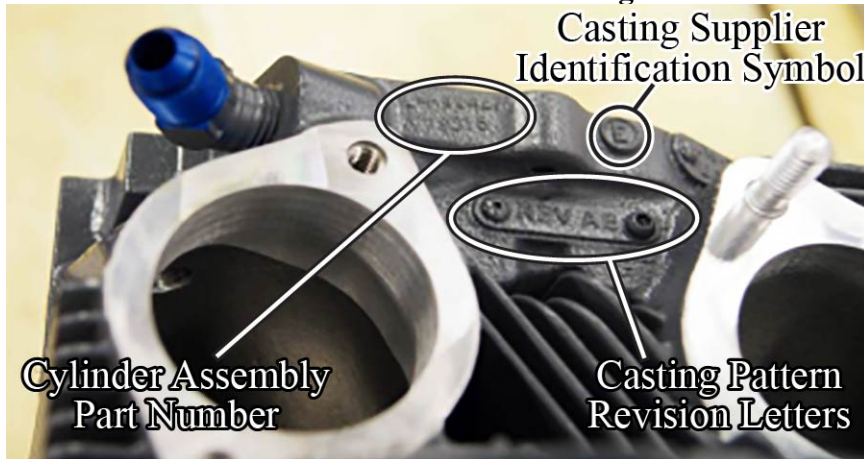
Figure 1

1. Refer to the casting marking locations shown in Figures 1 and 2 and find the casting markings on the Cylinder and Head Assembly.
2. Compare the casting markings to those identified for Cylinder and Head Assemblies in Table 1.

Identification on the Casting

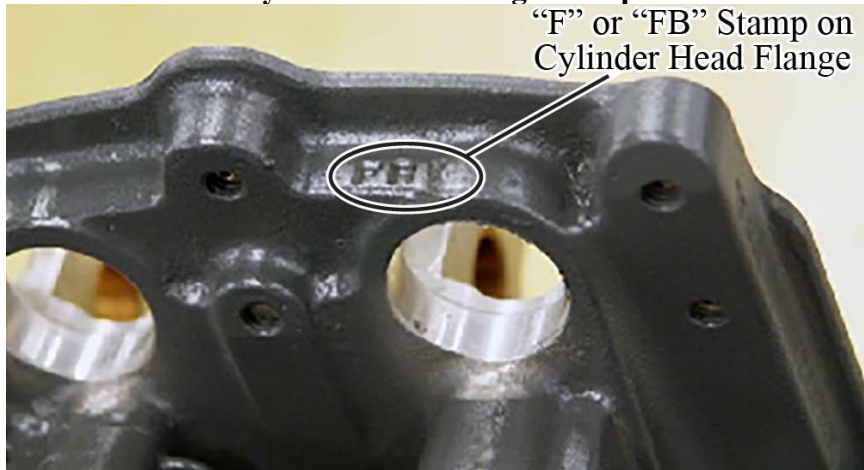
Figure 2

Cylinder Head Flange Stamp
