FLIGHT CONTROLS - REMOVE AND REINSTALL INVERTED LEFT AILERON TRIM TAB PUSHRODS

208	20800615 thru 20800653
208B	208B5454 thru 208B5522

CAL-27-09
September 17, 2019	Page 1 of 5

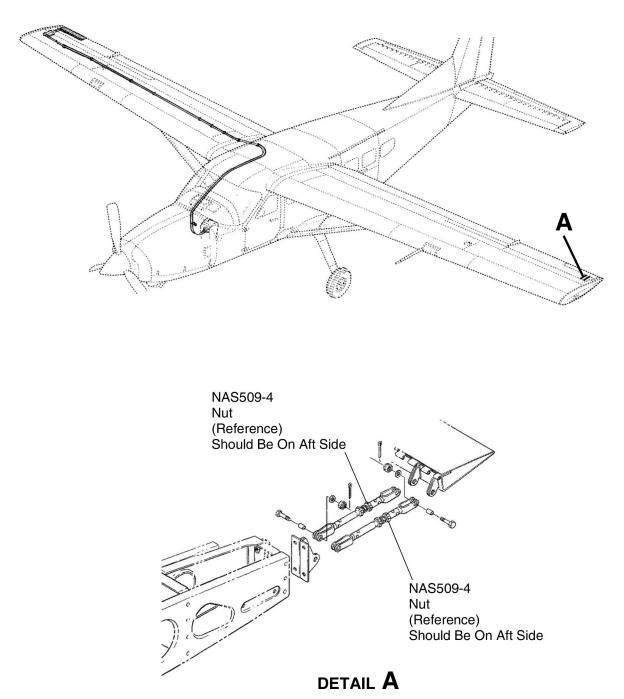
Figure 1. Remove and Reinstall Inverted Aileron Trim Tab Pushrods (Sheet 1)

Left aileron trim tab pushrods may be inverted.

- 2. (Refer to Figure 1, Sheet 1.) Locate the 2622260-4 Trim Tab Push Rod Assembly, which is on the lower side of the left wing tip.
- 3. (Refer to Figure 1, Sheet 1.) Use a mirror to determine if the pushrod's NAS509-4 Nut is installed on the forward or aft side of the wing.

- A. If the NAS509-4 Nut is installed on the aft side of the wing, no further action is required. Go to Step 9.
 - B. If the NAS509-4 Nut is installed on the forward side of the wing, the pushrod must be adjusted. Go to Step 4.

- 6. Remove, reverse and reinstall the existing 2622260-4 Trim Tab Push Rod Assembly so that the NAS509-4 Nut is on the aft side of the wing. (Refer to Cessna Model 208/208B Maintenance Manual, Chapter 27, Aileron Trim System Maintenance Practices.)
- 7. Install access panel 551AB. (Refer to Cessna Model 208/208B Maintenance Manual, Chapter 6, Access Plates and Panels Identification Description and Operation.)
- 8. Install 575AB fuel vent (wing tip). (Refer to Cessna Model 208/208B Maintenance Manual, Chapter 6, Access Plates and Panels Identification Description and Operation.)
- 9. Remove the maintenance warning tags and connect the airplane battery.
