SERVICE BULLETIN

Supersedes SB15-4
TECHNICAL PORTIONS
FAA APPROVED

SUBJECT: Champion Aerospace SLICK Service Bulletin
SB1-15A

PURPOSE: Potential decreased service life of SLICK 4-cylinder magneto distributor gear assemblies.

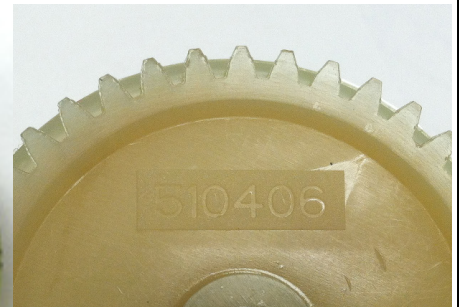
Figure 4. K3008 Distributor Gear Marked 510406 (Backside)

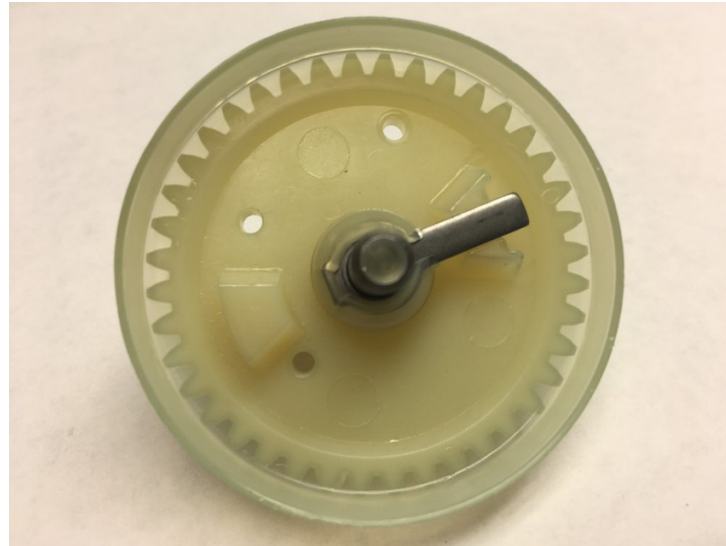
Figure 5. K3008 Distributor Gear With Monel Electrode
