IGNITION - TRANSMITTAL OF CONTINENTAL MOTORS SB15-4A, LYCOMING SB 622A, AND CHAMPION AEROSPACE SLICK SERVICE BULLETIN SB1-15A

SEL-74-05
Page 1 of 5

TO: Aircraft Manufacturers, Aircraft Engine Manufacturers, Distributors, Dealers, Engine Maintainers, Engine Overhaul Facilities, Owners and Operators of Slick Aircraft Magnetos.

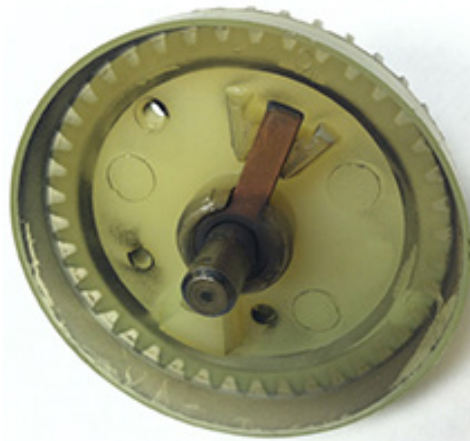
The initial release of SB1-15 was based on a limited number of field reports and product returns, Champion Aerospace has identified a possible condition in the distributor gear assemblies of 4-cylinder magnetos that can lead to decreased service life. Some of the returned products contained distributor gears exhibiting loosening of the electrode finger. This condition was observed in magnetos with a varying number of service hours. Typical symptoms are unusual RPM drop during magneto check, difficulty starting, and/or rough running engines.

Figure 3. Affected K3008 Distributor Gear With Copper Electrode

COMPLIANCE: REMOVE affected distributor gear assembly in subject magnetos and REPLACE with replacement distributor gear assembly, K3008, as soon as possible, not to exceed the next 50 hours. Document Service Bulletin compliance as written entry in applicable Aircraft and/or Engine logbook.

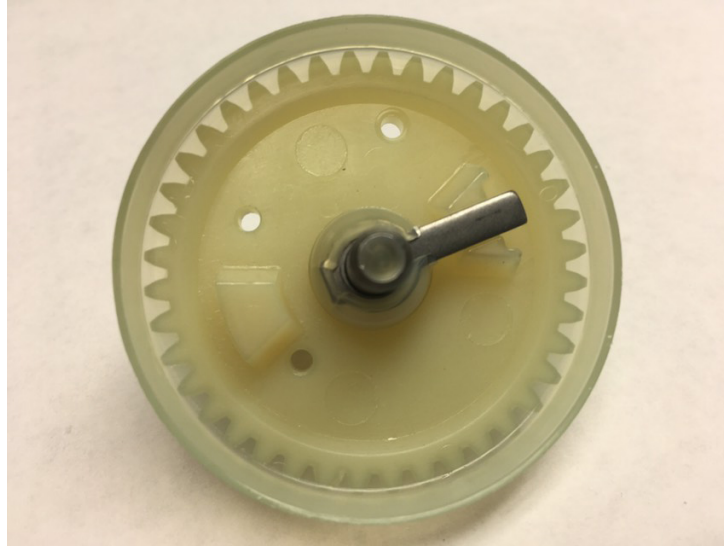
Figure 5. K3008 Distributor Gear With Monel Electrode

REMOVE K3008 distributor gear assembly in subject magnetos and REPLACE with replacement K3008 distributor gear assembly **as soon as possible**, not to exceed the next 50 hours.

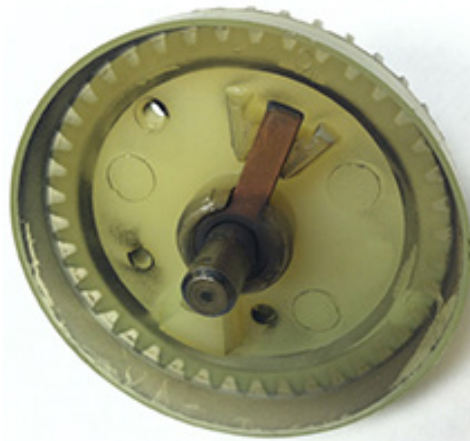
The initial release of SB1-15 was based on a limited number of field reports and product returns, Champion Aerospace has identified a possible condition in the distributor gear assemblies of 4-cylinder magnetos that can lead to decreased service life. Some of the returned products contained distributor gears exhibiting loosening of the electrode finger. This condition was observed in magnetos with a varying number of service hours. Typical symptoms are unusual RPM drop during magneto check, difficulty starting, and/or rough running engines.

Figure 3. Affected K3008 Distributor Gear With Copper Electrode

COMPLIANCE: REMOVE affected distributor gear assembly in subject magnetos and REPLACE with replacement distributor gear assembly, K3008, as soon as possible, not to exceed the next 50 hours. Document Service Bulletin compliance as written entry in applicable Aircraft and/or Engine logbook.

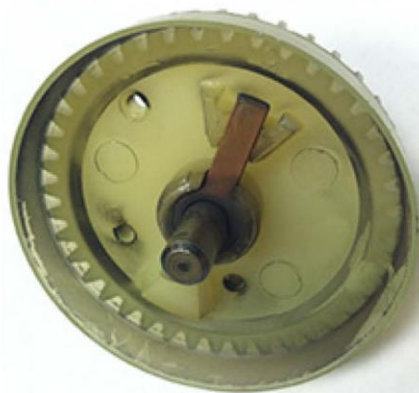
The initial release of SB1-15 was based on a limited number of field reports and product returns, Champion Aerospace has identified a possible condition in the distributor gear assemblies of 4-cylinder magnetos that can lead to decreased service life. Some of the returned products contained distributor gears exhibiting loosening of the electrode finger. This condition was observed in magnetos with a varying number of service hours. Typical symptoms are unusual RPM drop during magneto check, difficulty starting, and/or rough running engines.

Figure 3. Affected K3008 Distributor Gear With Copper Electrode

COMPLIANCE: REMOVE affected distributor gear assembly in subject magnetos and REPLACE with replacement distributor gear assembly, K3008, as soon as possible, not to exceed the next 50 hours. Document Service Bulletin compliance as written entry in applicable Aircraft and/or Engine logbook.

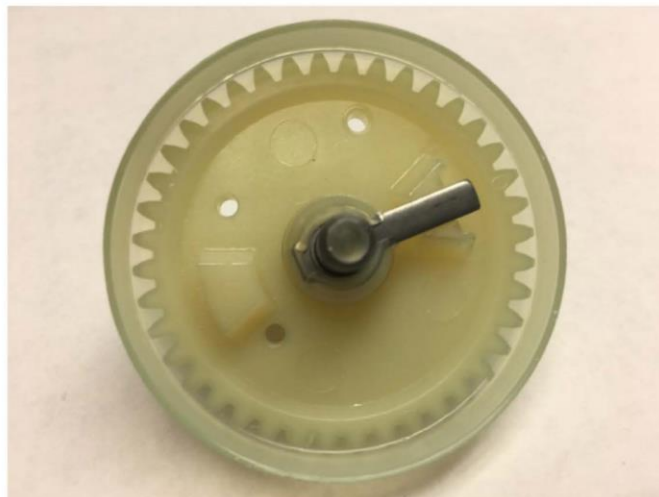
Figure 5. K3008 Distributor Gear With Monel Electrode

REMOVE K3008 distributor gear assembly in subject magnetos and REPLACE with replacement K3008 distributor gear assembly **as soon as possible**, not to exceed the next 50 hours.
