POWER PLANT - INSPECT FOR MISSING WASHERS ON THE ROCKER COVERS

172S

SERIAL NUMBERS172S12281 thru 172S12293, 172S12303 thru
172S12310, 172S12312**REASON**

SEL-71-12
Page 1 of 6

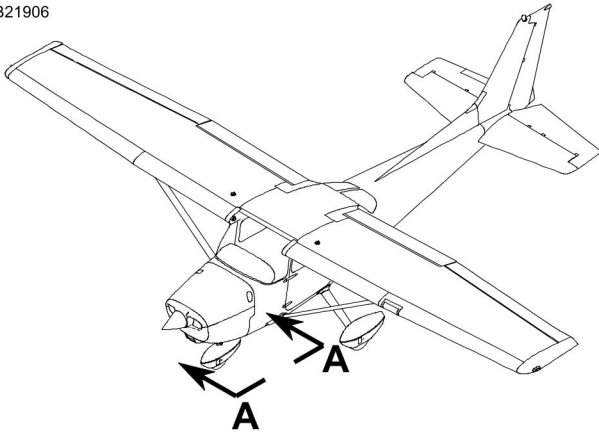
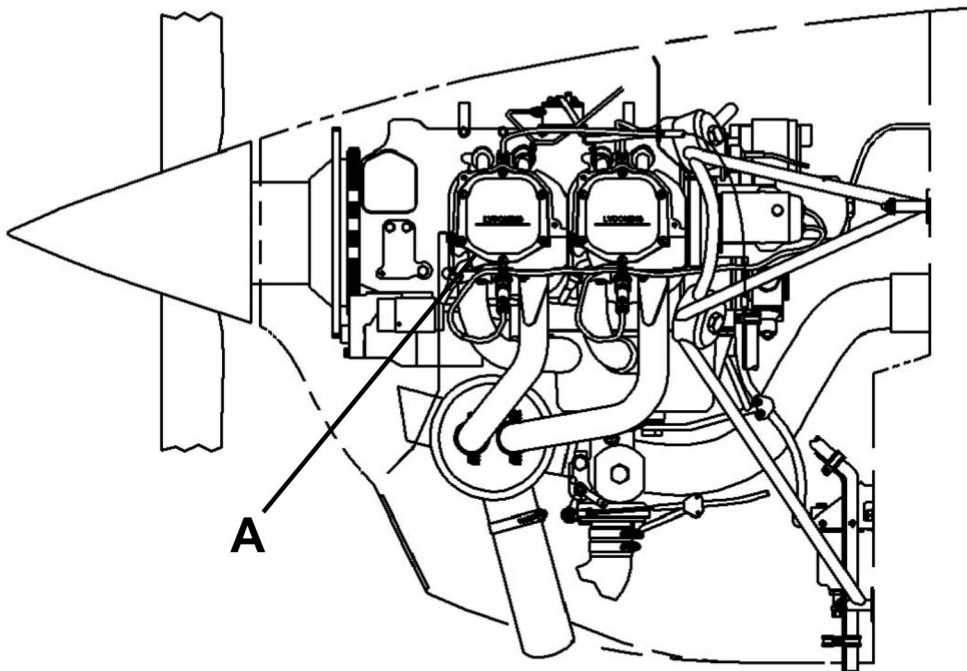
Figure 1. Washer Inspection (Sheet 1)

To inspect for missing washers on the rocker covers which could cause damage/cracking to the support bracket.

2. Remove the engine cowl. (Refer to the Model 172R/172S Maintenance Manual, Chapter 71, Cowl - Maintenance Practices.)
3. (Refer to Figure 1, View A-A and Detail A.) Inspect the left and right rocker boxes.

- A. If the two NAS1149F0463P Washers are installed on the left rocker box as shown go to Step 3.C.
 - B. If the two NAS1149F0463P Washers are not installed on the left rocker box as shown, do the steps that follow:

- 8 Attach the 2455034-1S Support Bracket to the structure with two MS20426AD4-4 Rivets.
- (3) Install the two NAS1149F0463P Washers and the kept screw.

- (4) Torque the fasteners to 96 to 106 inch-pounds. (Refer to Lycoming Special Service Publication No. SSP-1776-4.)
- C. Do Step 3.A and 3.B for the right side.

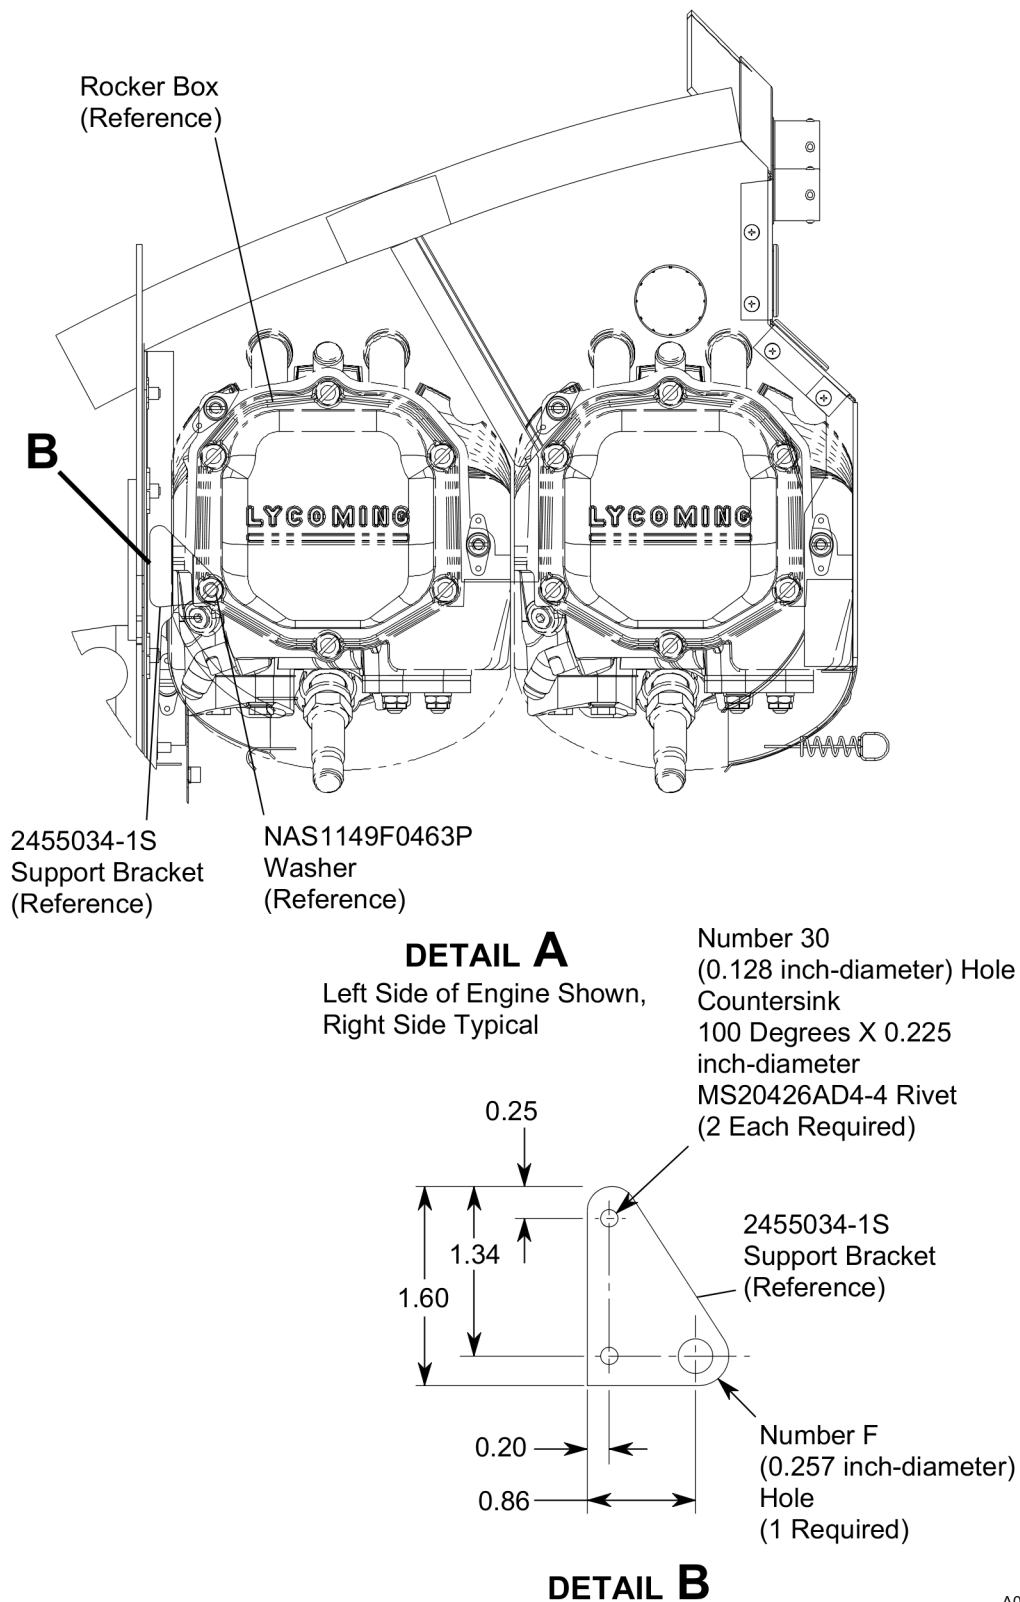
Figure 1. Washer Inspection (Sheet 2)

- (1) Remove the screw from the left rocker box.
 - (2) (Refer to Figure 1, Detail A and Detail B.) Inspect the support bracket.
 - (a) If the support bracket is not bent or cracked, go to Step 3.(B).(3).

- (b) If the support bracket is bent or cracked, do the steps that follow:
- 1 Remove the current 2455034-1S Support Bracket.
 - 2 Put the new 2455034-1S Support Bracket on the removed 2455034-1 Support Bracket.

- 3 Drill two Number 30 (0.128 inch-diameter) holes in the 2455034-1S Support Bracket to match the holes in the removed 2455034-1 Support Bracket.
 - 4 Countersink the holes in the 2455034-1S Support Bracket 100° x 0.225 inch-diameter.

- 5 Deburr the holes that were drilled.
 - 6 Apply U074093 color chem film treatment to the drilled holes.
 - 7 Apply K000574 corrosion resistant primer to the drilled holes.
