SERVICE BULLETIN

CAB-33-07

LIGHTS - LED NAV/ANTI-COLLISION LIGHT WIRING MODIFICATION

208B

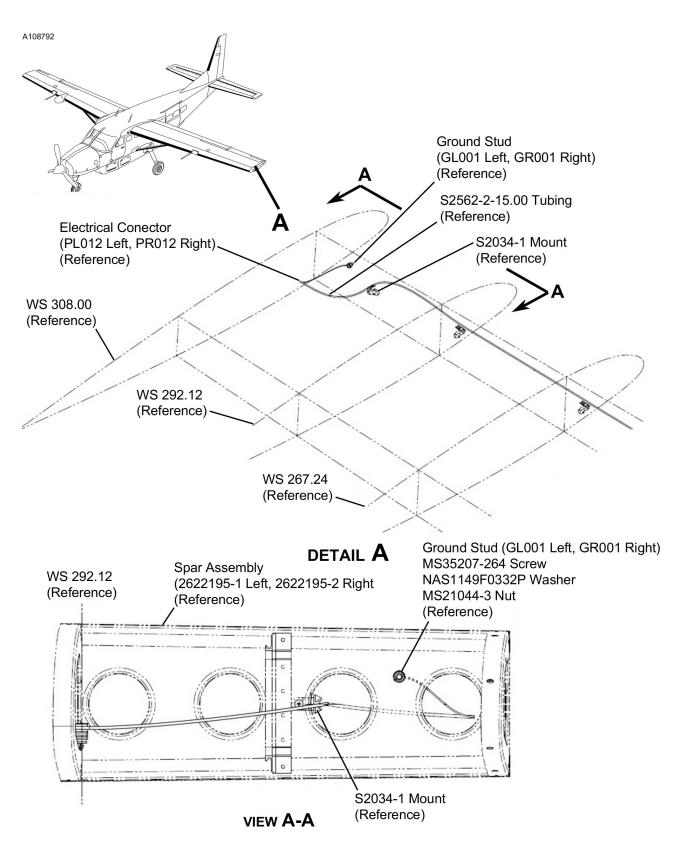
Figure 1. LED NAV/Anti-Collision Light Wiring Modification (Before Modification) (Sheet 1)

Field reports indicate that the magnetometer is experiencing Red-X situations. It was found that the Red-X was caused by the LED Nav/Anti-Collision Lights. Removal of the ground shield eliminates the interference with the magnetometer.

- 4. (Refer to Figure 1, View A-A.) Remove the terminal ends from the GL001 (Left) and GR001 (Right) Ground Studs on the 2622195-1 (Left), 2622195-2 (Right) Spar Assemblies.
 - A. Install the removed hardware on the ground studs and tighten.

- 5. Cut the shielded wire to remove the terminal end that was removed from the GL001 (Left), GR001 (Right) Ground Studs.
- 6. Install the TC4001 End Cap on the end of the shielded wire. (Refer to the Model 208/208B Maintenance Manual, Chapter 20, Bonding and Grounding Maintenance Practices.)
 - A. Heat shrink the TC4001 End Cap until it has shrunk firmly around the shielded wire.
