**MANDATORY****MEL-57-04****TITLE**

WINGS - DETAILED INSPECTION OF FORWARD SPAR UPPER CAP

402C

402C0001 thru 402C1020

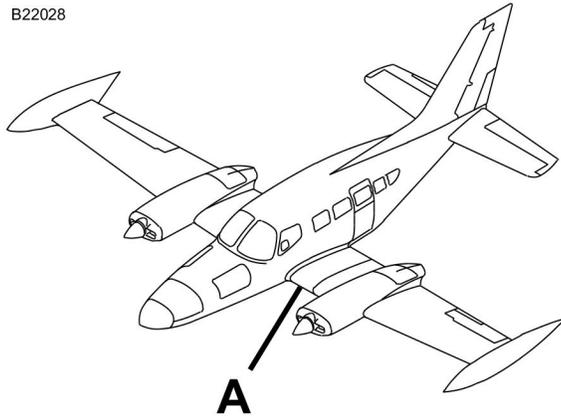
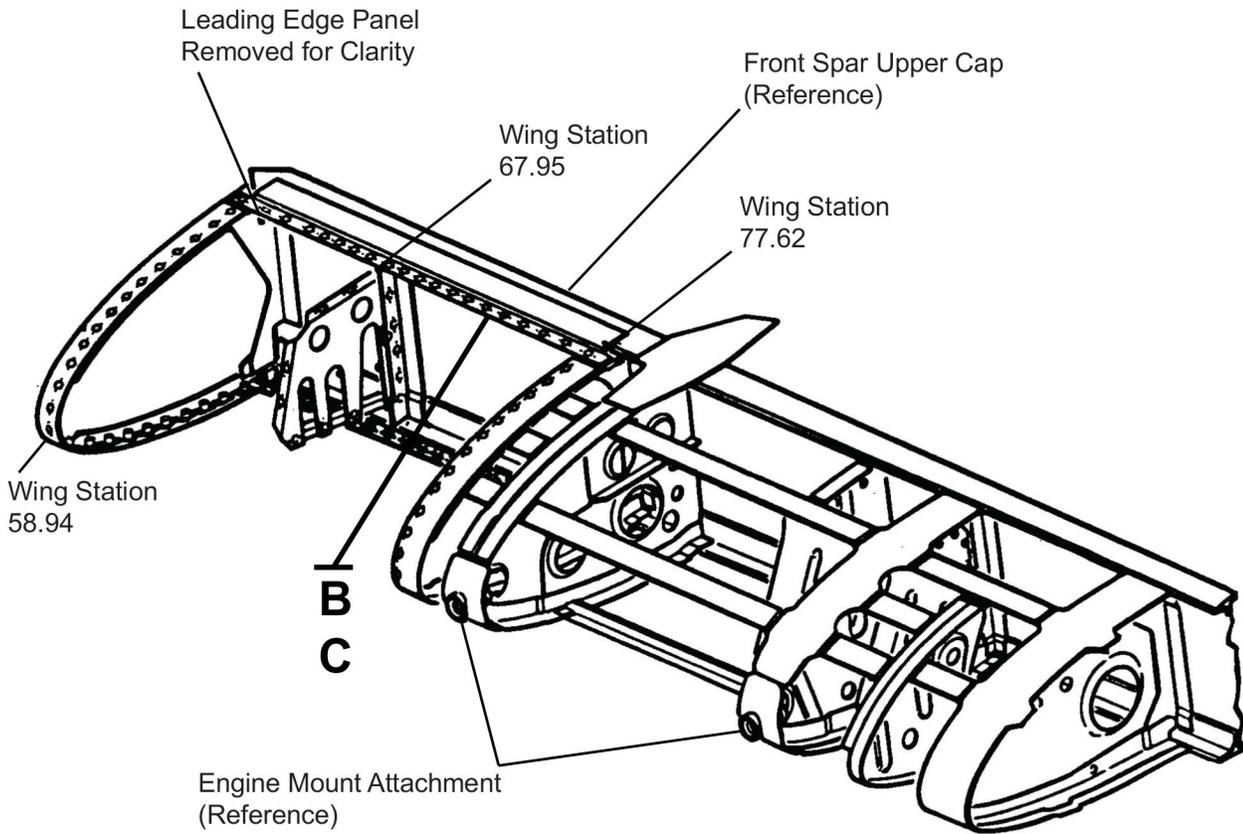
Figure 1. Forward Spar Upper Cap Inspection (Sheet 1)

**NOTE:** The area to clean for the inspection will be between Wing Station 58.94 and Wing Station 77.62.

- A. Use a suitable light source and a 10X Magnifying Lens to inspect the forward spar and upper cap.
  - B. If a crack is found, no further flight is permitted. Contact Textron Aviation Team Structures at: [structures@txtav.com](mailto:structures@txtav.com), or phone: 316-517-6061.

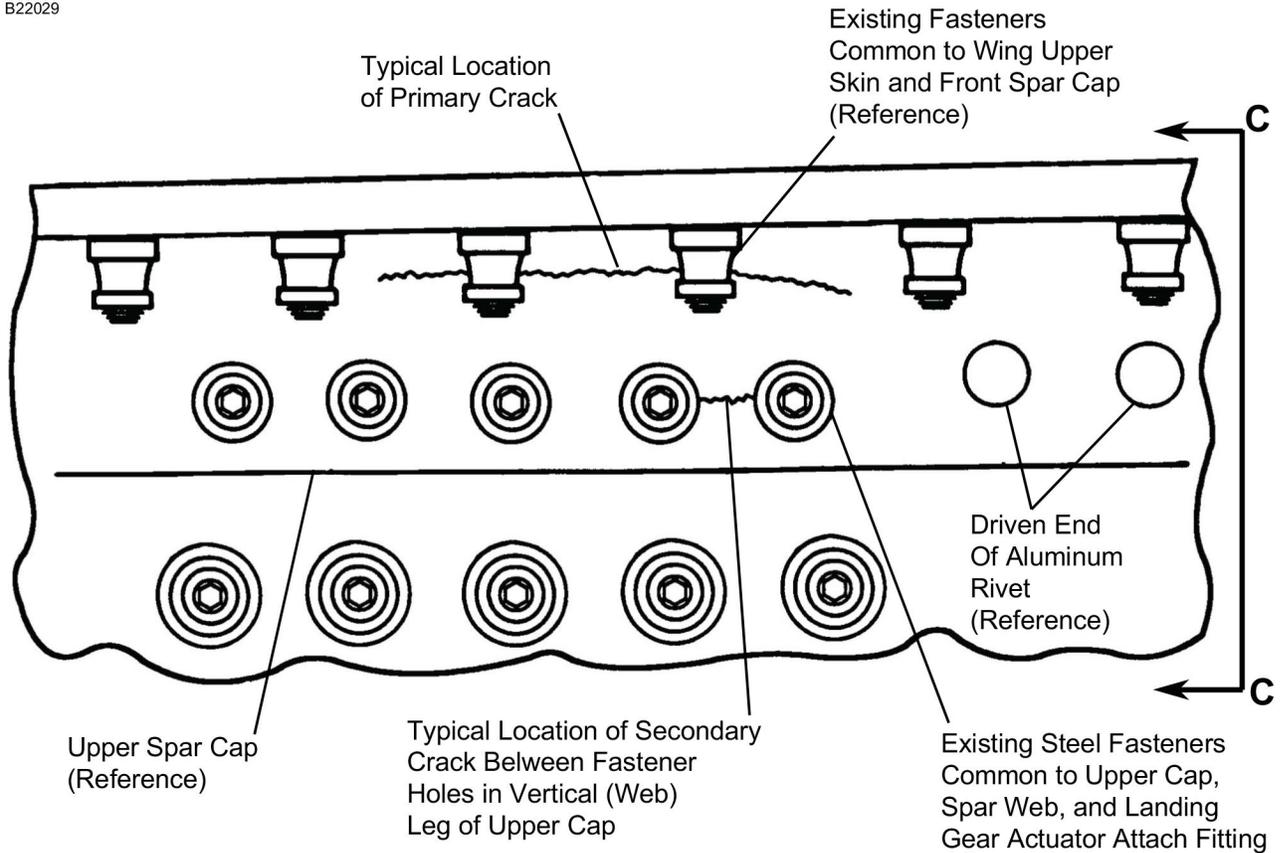
**DETAIL B**

View Looking Aft at Upper LH Front Spar Cap - RH Opposite

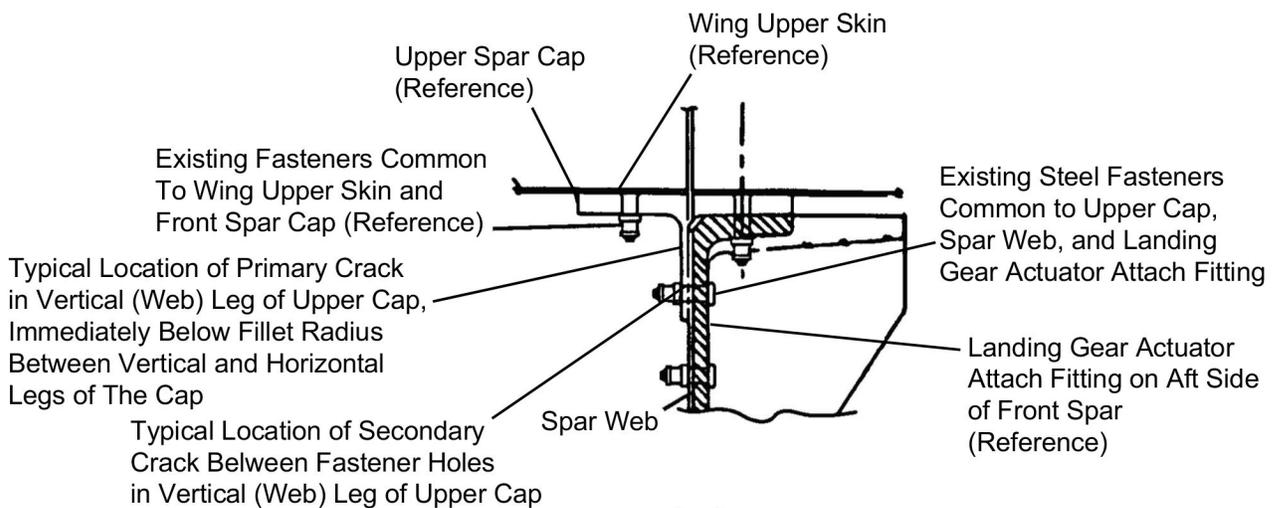
**VIEW C-C**

Looking Outboard at LH Front Spar Upper Cap - RH Opposite

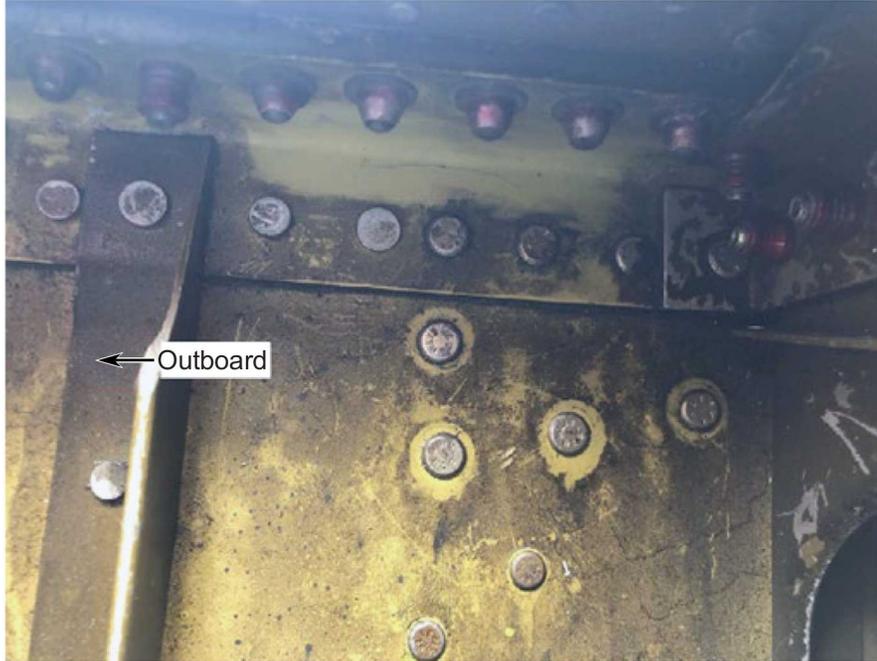
**DETAIL C**

M402C Front Spar Upper Cap General Crack Location W.S 65.59

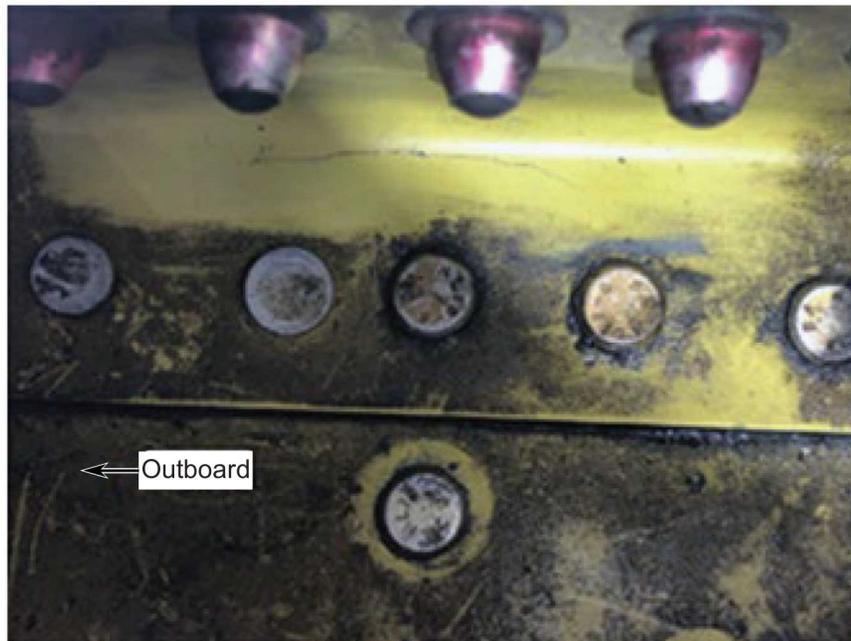
**DETAIL C**

M402C Front Spar Upper Cap General Crack Location W.S 65.59
