SERVICE LETTER

MANDATORY MEL-79-01

OIL - TRANSMITTAL OF CONTINENTAL AEROSPACE TECHNOLOGIES CSB07-1A CONNECTING ROD PISTON PIN BUSHING INSPECTION

SUBJECT: Connecting Rod Piston Pin Bushing Inspection

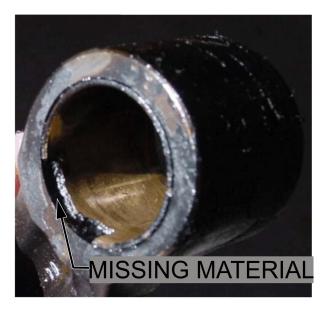
Figure 3. Typical Indications of Bushing Fragments

If piston pin bushing material (see Figure 3) is recovered from an engine, remove the cylinders, pistons, and piston pins (no more than two cylinders at a time) to inspect the connecting rod piston pin bushings. In addition, the piston pin bushing must be inspected for condition each time a cylinder is removed for any reason.

CONNECTING ROD
AND BUSHING

- 1. Remove the cylinders and pistons from the engine using the instructions contained in the appropriate maintenance or overhaul manual to gain access to the piston pin bushings.
- 2. Inspect the connecting rods according to the instructions in M-0, Section 10-9.4.
- 3. Visually inspect the piston pin bushing for any signs of cracks emanating from the piston pin bushing split line, missing bushing material, or signs of bushing movement.
- 4. Inspect the piston pin bushing for wear according to the instructions in **M-0**, Standard Practice Maintenance Manual, *Section 10-9.4*.
 - a. Replace any piston pin bushing that does not meet the installation criteria in **M-0**, Section 10-9.4 or is found cracked per during the inspection in step 3.
 - b. Replace any piston pin bushing that does not meet the inspection criteria in M-0, Standard Practice Maintenance Manual, *Section 10-9.4*.
