National Transportation Safety Board Aviation Accident Preliminary Report

Location:	Lake Havasu City, AZ	Accident Number:	WPR21FA340
Date & Time:	September 12, 2021, 16:09 Local	Registration:	N2085Q
Aircraft:	Cessna 177RG	Injuries:	1 Fatal
Flight Conducted Under:	Part 91: General aviation - Personal

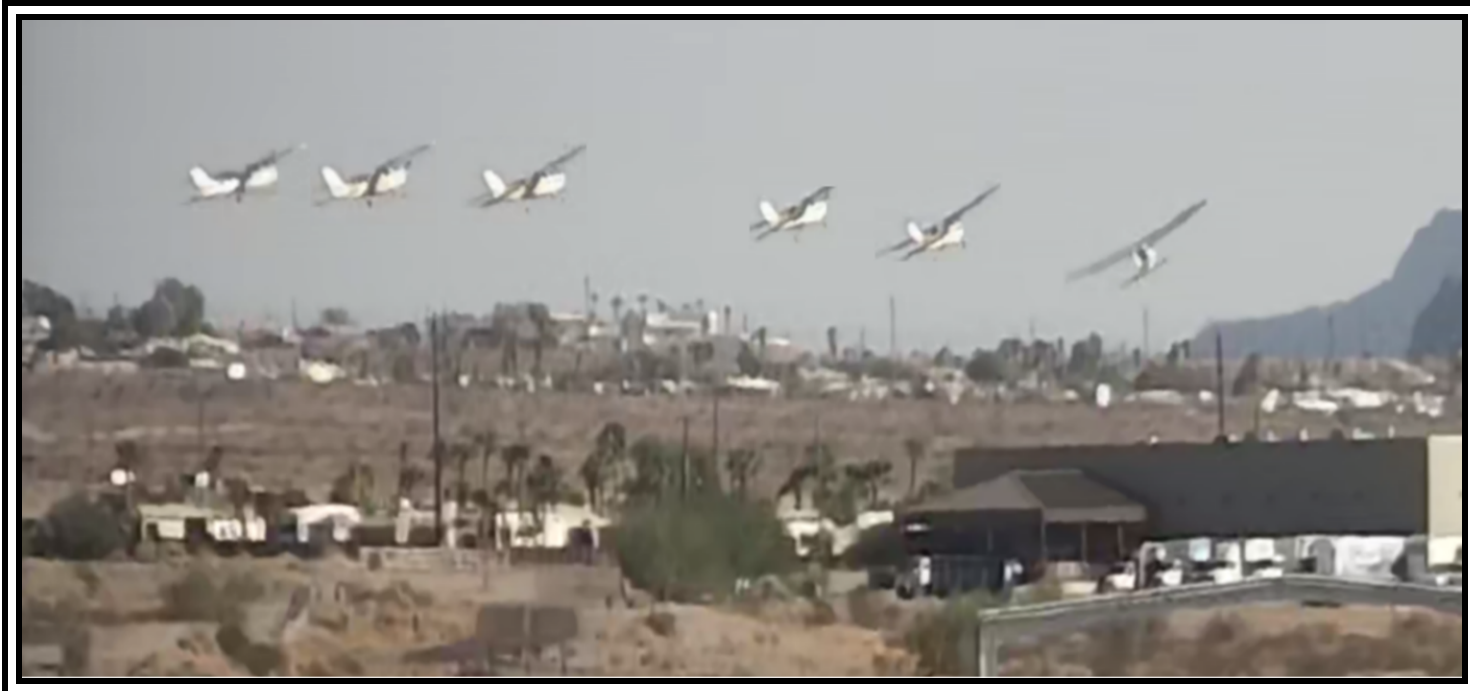
Investigators reviewed video recordings, audio recordings, and flight track data covering the area of the accident during the time surrounding the accident using Federal Aviation Administration (FAA) provided Automatic Dependent Surveillance-Broadcast (ADS-B) data. The airplane taxied to runway 14 and after performing a run-up, departed about 1608. Witnesses report that they observed the airplane takeoff down the runway at a slow groundspeed and noted that the engine sounded rough as though it was making partial power. The airplane did not ascend as expected and veered to the right of the centerline reaching 100-150 feet agl (see Figure 1 below). The ADS-B data shows the airplane accelerating down the runway up to a derived airspeed of 65 kts. The

Figure 1: Security Camera Footage Showing Initial Right Turn

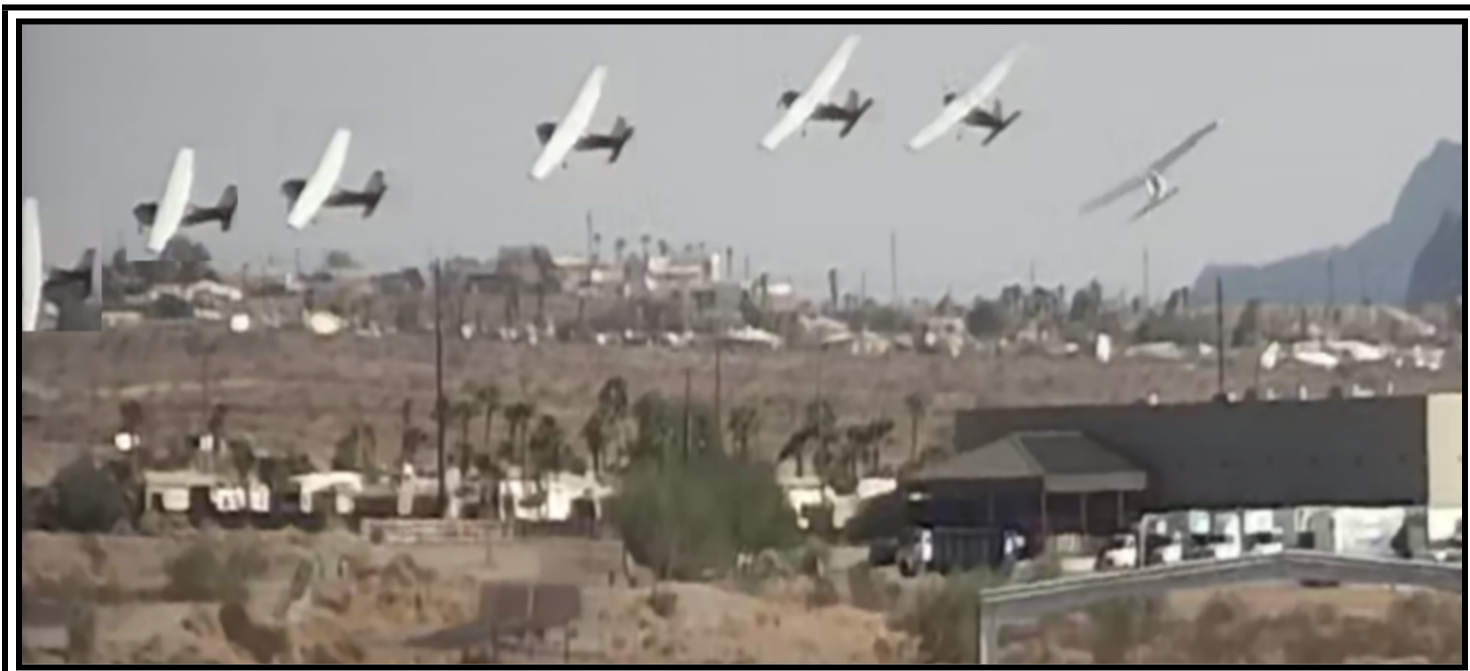
The airplane then pitched up to a nose-high attitude and made an aggressive left bank consistent with pilot attempting to make 180-degree turn back to the runway (see Figure 2 below). Witnesses observed the airplane's wingspan turn nearly perpendicular to the horizon and then stall with the left wing dropping toward terrain.

Figure 2: Security Camera Footage of Bank to the Left

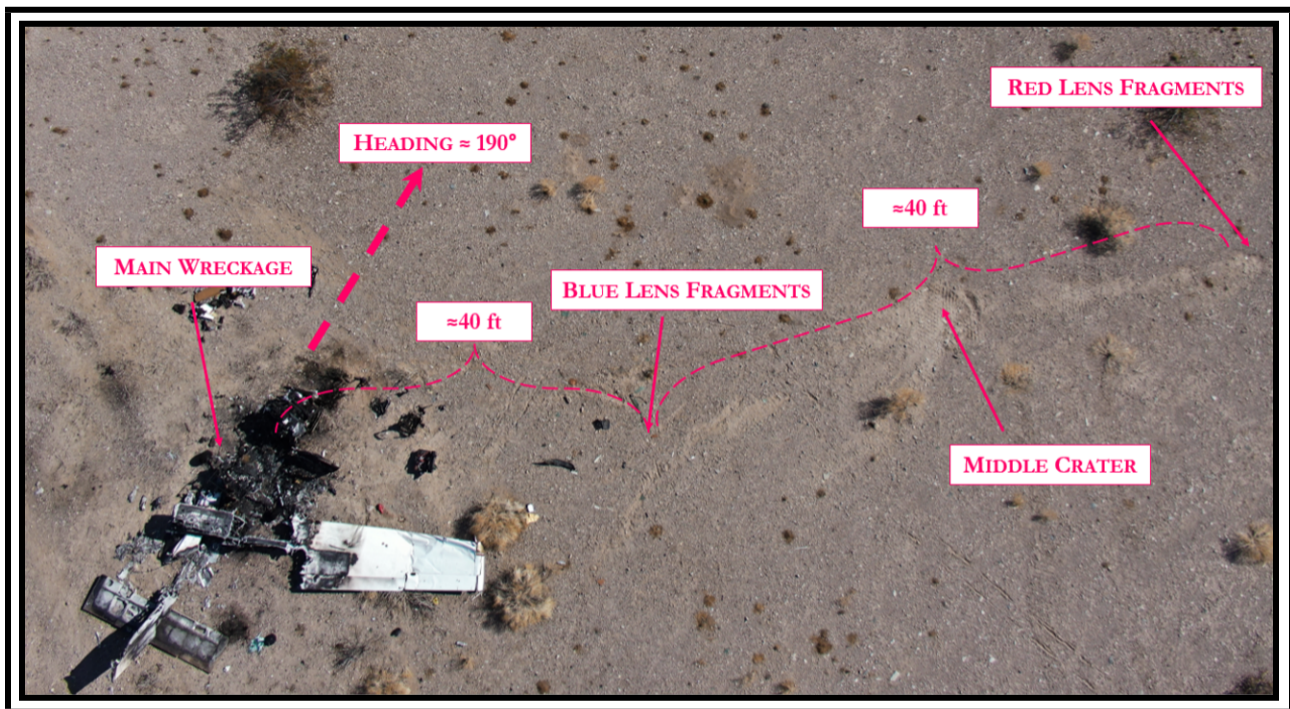
The accident site was located in the desert terrain about 830 ft from the end of runway 14 at an elevation of 790 feet msl. In character, the terrain was composed of dry, soft dirt with sparse brush. The wreckage was found distributed over a 200 ft distance on a median magnetic bearing of about 60°. The main wreckage consisted of a majority of the airframe and engine, which had been consumed by fire with the exception of the right wing. The first identified points of contact consisted of disrupted dirt on the flat desert terrain making up the far east-southeast end of the debris field. The markings started as an indentation in dirt with shards of red lens fragments imbedded within the soil consistent with the left-wing tip impacting first. The crater was continuous toward the main wreckage with the end of the crater having blue/green lens fragments imbedded (see Figure 3 below). A larger center indentation was found in between the red lens fragments and the green/blue lens fragments and had a large arc-shaped disruption of dirt consistent with a rotating propeller blade.

Figure 3: Main Wreckage in Reference to First Identified Point of Impact

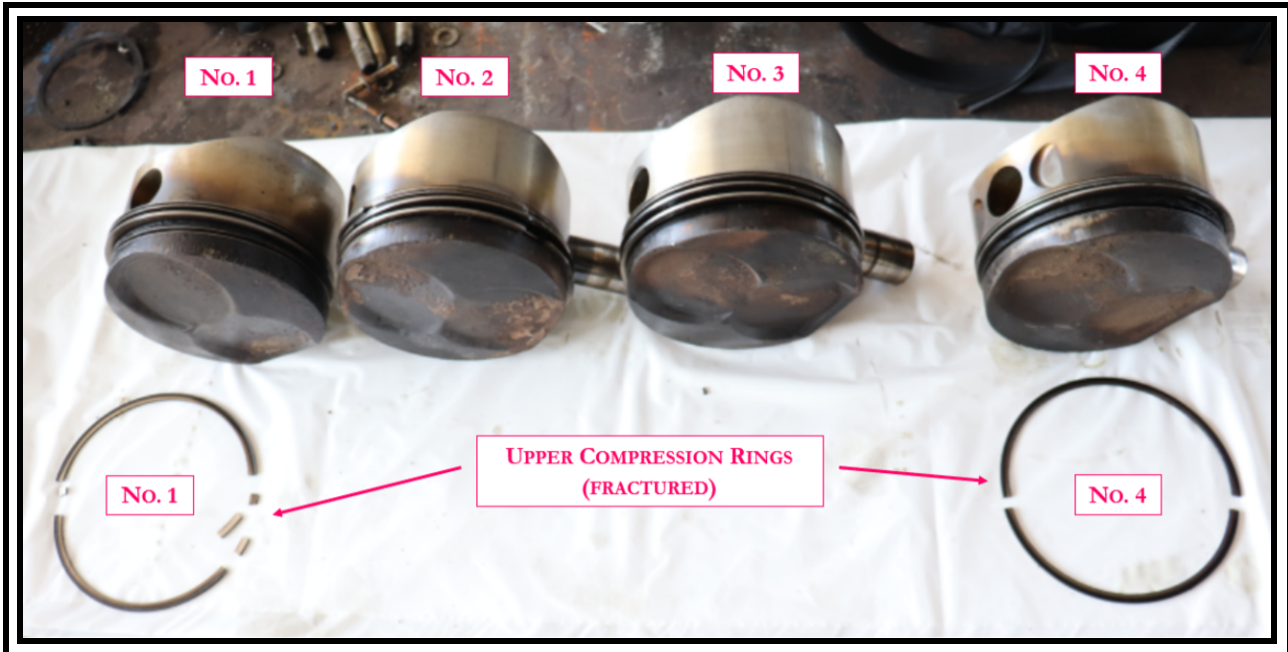
As part of the post-accident examination, a majority of the engine and its respective components were completely disassembled. In pertinent part, the Nos. 1 and 4 top compression piston-rings were fragmented (see Figure 4 below). On all the piston skirts there was evidence of corrosion and wear with light scuffs/grooves oriented from the base to the crowns. There was additionally evidence of blow-by with heat signatures on the piston skirts on all cylinders, but the least damage was on the No. 3 cylinder.

Figure 4: All Pistons (Showing Fractured Rings)

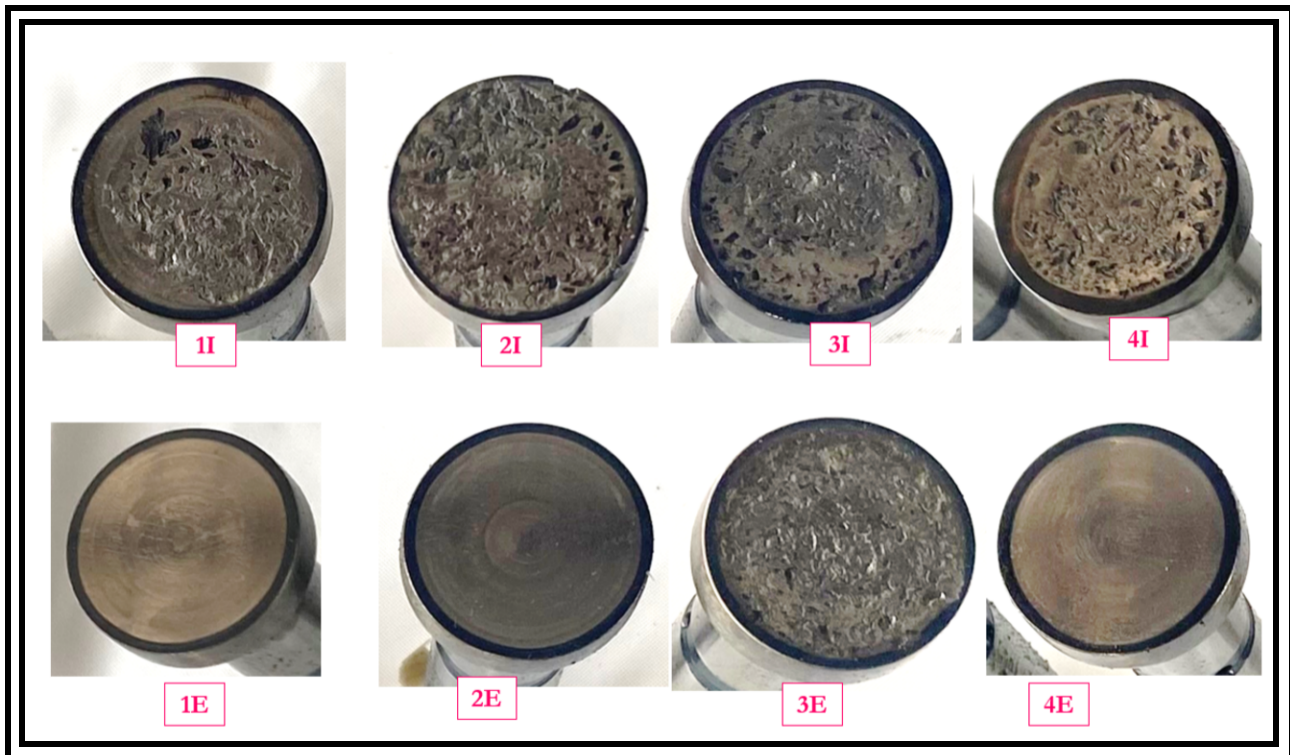
Separation of the crankcase halves revealed that there was severe spalling on the faces of all the intake lifters and the No. 3 exhaust lifter; there was also evidence of galling noted. On the remaining lifters there was evidence of wear with a circular pattern and pitting (see Figure 5 below) The camshaft revealed signatures of excessive wear on the cam lobes including rounding of the lobes, pitting and material deformation observed on the lobes.

Figure 5: Lifter Face Wear Signatures (intake lifters above and exhaust below)

The lifter on the No. 4 exhaust valve had a tear in the base of the body, consistent with contact with the hydraulic socket; the pushrods did not show evidence of being bent. The bearings showed light wear and the crankshaft had light rotational scoring.
