# National Transportation Safety Board Aviation Accident Preliminary Report

<b>Location:</b>	Danville, VA	<b>Accident Number:</b>	ERA22FA114
<b>Date &amp; Time:</b>	February 1, 2022, 10:06 Local	<b>Registration:</b>	N622QT
<b>Aircraft:</b>	Cessna 310	<b>Injuries:</b>	1 Fatal
<b>Flight Conducted Under:</b>	Part 91: General aviation - Aerial observation

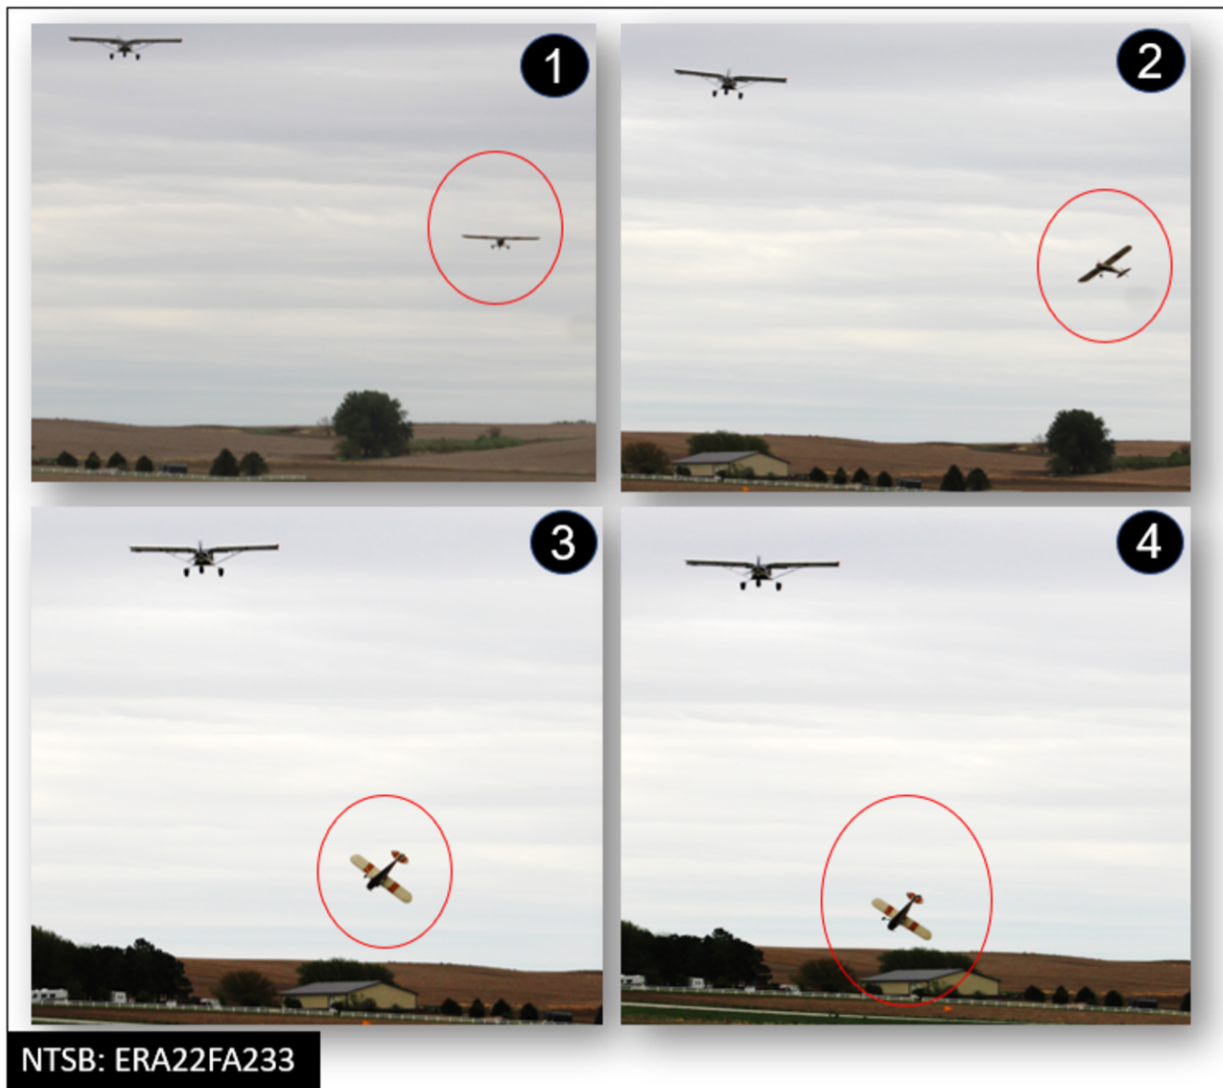
Figure 1: Four photographs showing the right roll and descent

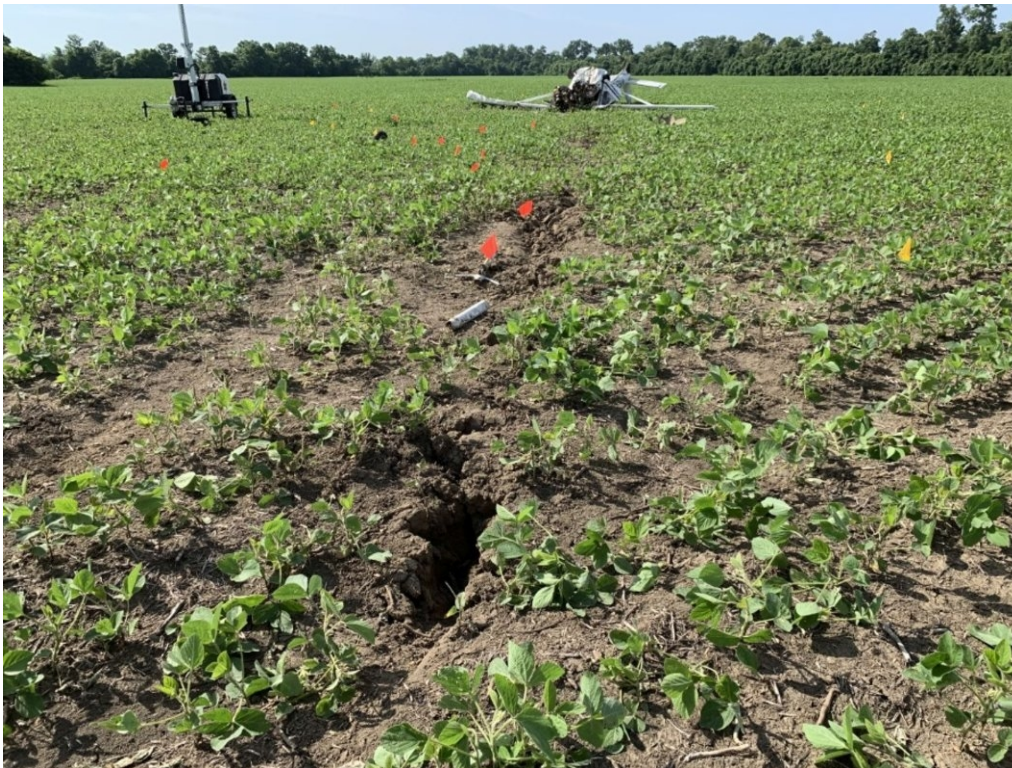
The airplane impacted a soybean field about 3 miles west-southwest from M01. The initial ground mark appeared consistent with impact from the nose landing gear. The nose landing gear was separated and located within the debris path. The airplane came to rest inverted about 90 ft from the initial ground impact. The debris path was oriented on an approximate 150° bearing. The fuselage, right wing, and vertical stabilizer were damaged during impact.

*Photo 1 – Accident Site from Initial Ground Impact*

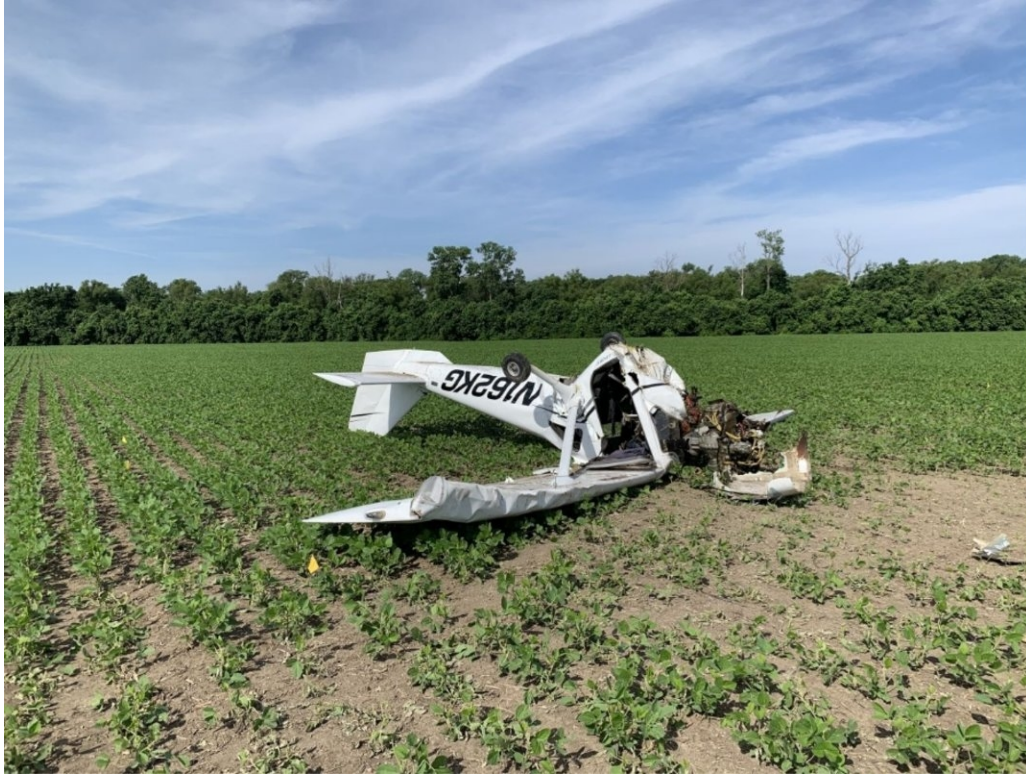
*Photo 2 – Airplane at Accident Site*

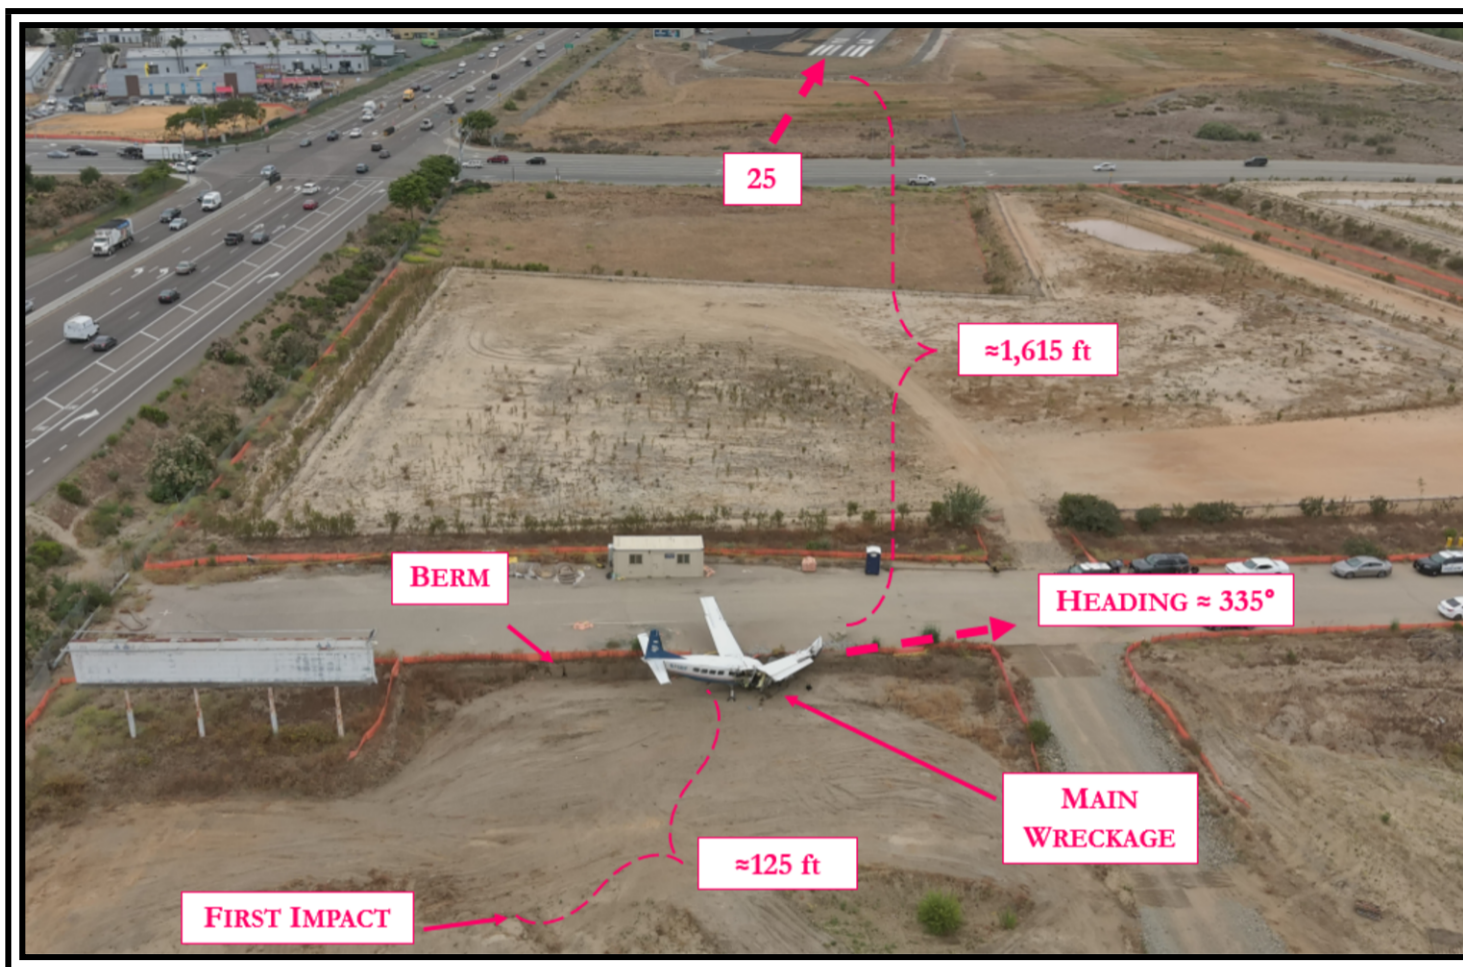
The accident site was located about 1,615 feet east of the approach end of runway 25 on flat terrain composed of soft, dry dirt. The wreckage was found distributed over an approximate 125-foot distance with the nose pointed on a heading of about 335°. The right wing was partially separate from the fuselage root and had folded forward and over upon itself, coming to rest inverted. The first identified piece of debris was fragments of left lens, consistent with the tip of the right wing contacting the ground at the beginning of the accident sequence (see Figure 4 below). The flaps were found in the retracted position. There was about 50 gallons of fluid, consistent in appearance and odor with JetA fuel, recovered from the right wing; no fluid was recovered from the left wing, but the fuel line had separated from the connection into the fuselage. The fuel system remained unbreached from the header tank to the engine's fuel nozzles. There was fluid found in the header tank, in the airframe fuel filter, and in several fuel lines before and after the fuel control unit. The preliminary findings from the engine teardown (e.g., several compressor blade tips curled in the opposite direction of rotation and metal splatter on the turbine discs and stators) were consistent with the engine running at a low power setting at the time of impact.

Figure 4: Accident Site in Reference to the Runway

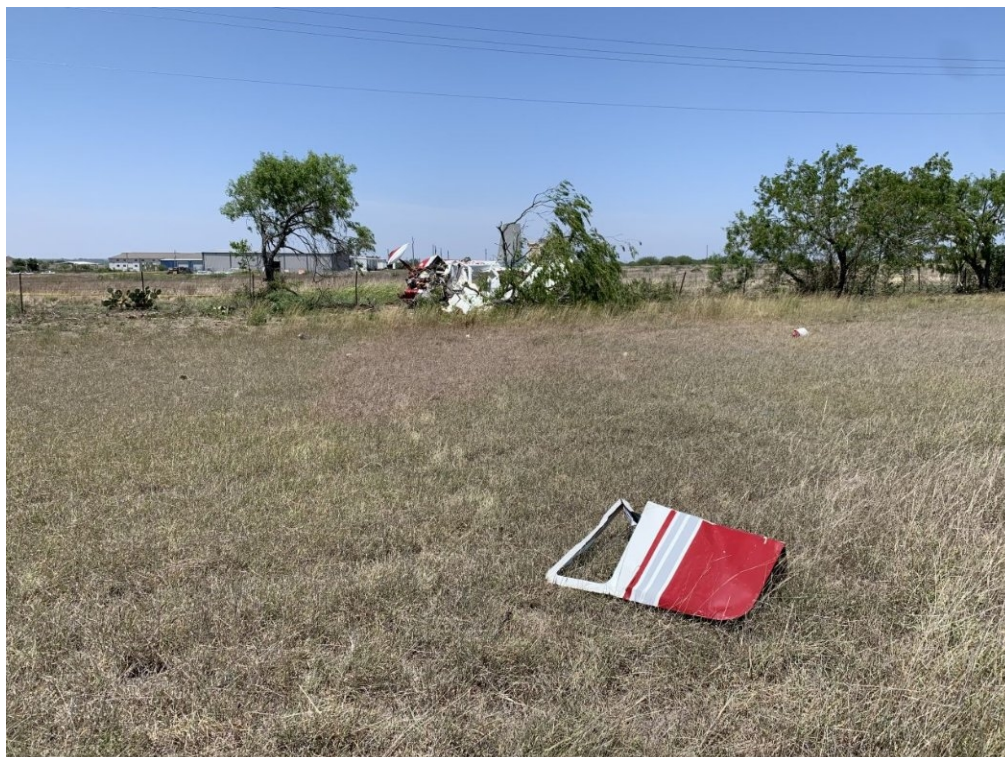
The accident site was located about 0.8 miles north of the runway 16 approach threshold at an approximate elevation of 368 ft. This was about 0.12 miles east of the final ADS-B data point. A ground impact scar was located about 18 ft west of the airplane wreckage. The wreckage came to rest along a wire fence and tree line. The fuselage and both wings exhibited damage consistent with impact forces, and the cockpit/cabin area was compromised.

Figure 2 – Accident Site

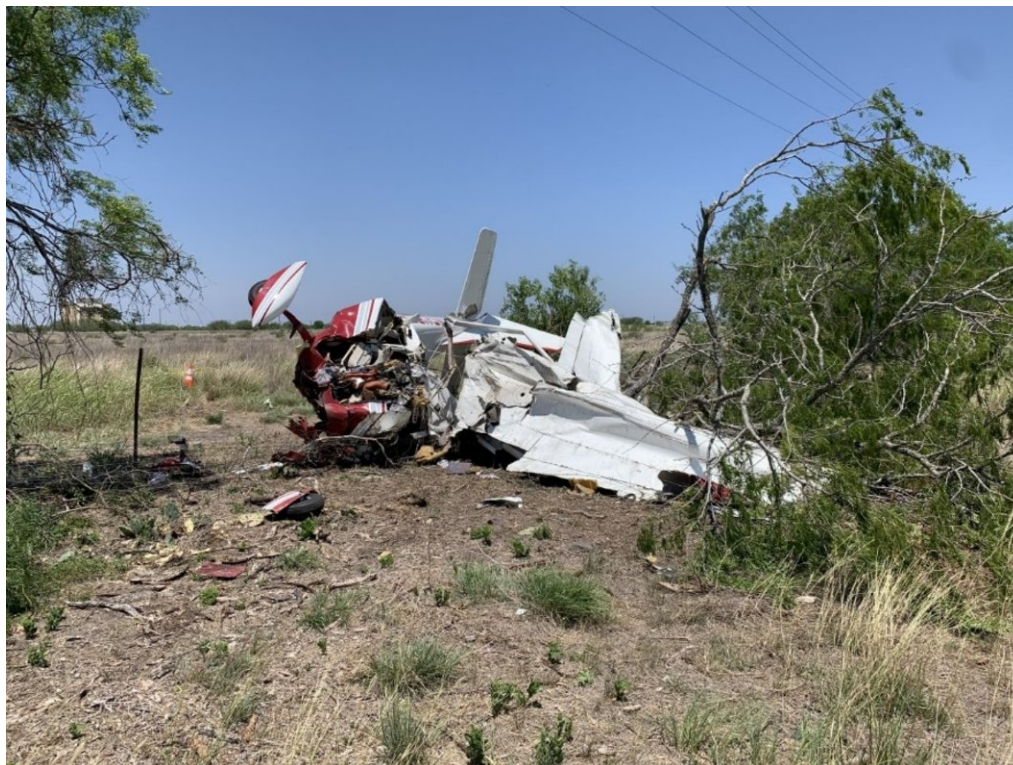
Figure 3 – Airplane Main Wreckage

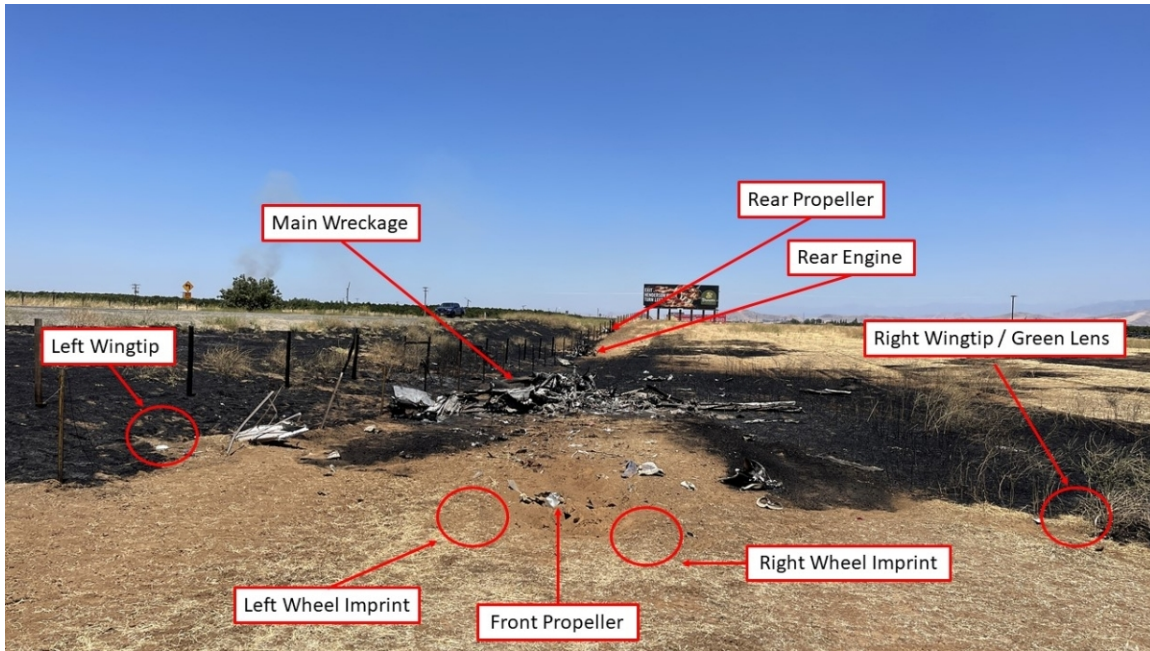
Examination of the accident site revealed that the airplane impacted an open field immediately adjacent to highway 65, about 2 miles southeast of PTV on a heading of about 338°. The wreckage debris path was about 234 ft in length and contained all major structural components of the airplane. The first identified point of contact (FIPC) was a ground scar, about 5.5 ft in length and about 8 ft wide, which contained the forward propeller and engine cowling fragments. On either side of the FIPC there were 2 distinct impact marks on the left and right side, consistent with the left and right main landing gear. Extending from the FIPC, were two distinct ground impressions, consistent with the left and right wings. The wreckage was recovered to a secure location for further examination.

Figure 2: Accident Site Diagram

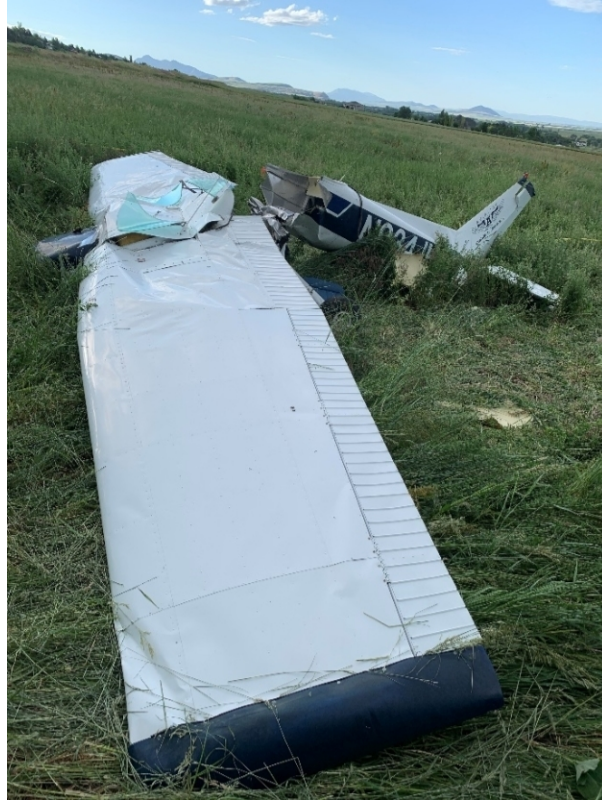
The airplane wreckage was located on upward sloping terrain in an agricultural area. The airplane in its entirety came to rest on a heading of 223°. The airplane impacted terrain in a nose down attitude, and the propeller hub with both propeller blades attached, separated from the propeller flange. The left and right wings were compressed forward toward the engine, emanating at the wing roots. The flaps and ailerons remained attached to their respective wing, in their entirety. The horizontal and vertical stabilizers remained attached in their entirety. The nose landing gear collapsed and folded aft, underneath the cabin seats. The left and right main landing gear remained attached to the lower fuselage, aft of the cabin.

Figure 1: View of the accident airplane at rest

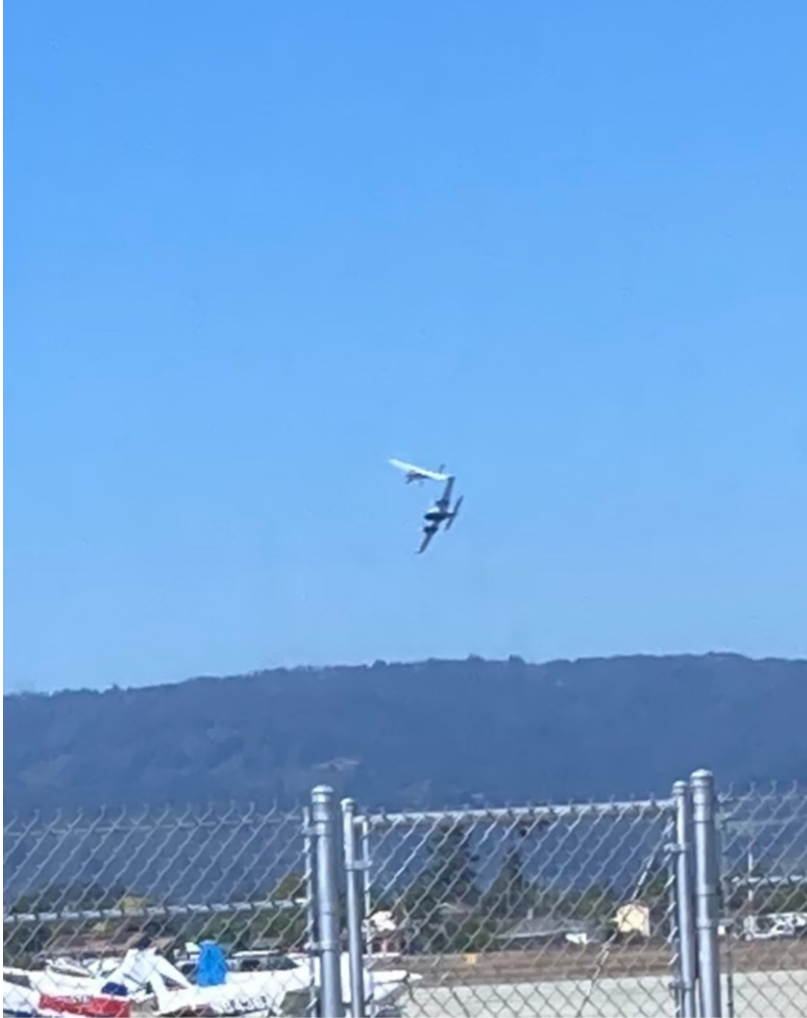
Multiple witnesses reported hearing the two pilots communicating over the CTAF, and others heard and observed the two airplanes collide. One witness stated that he was flying overhead of the airport at 1,300 ft mean seal level (msl) when he heard the two pilots on the CTAF. He focused his attention on the final approach path and observed the Cessna 340 “on the Cessna 152’s tail.” The Cessna 340 then banked to the right and its left wing struck the Cessna 152. He then observed both airplanes descend to the ground. Another witness who was in her office took a photo of the two airplanes as they approached the airport. The Cessna 340 appeared to be in a steep right bank and the Cessna 152 appeared to be in a slight nose-low attitude.

*Figure 2. Image captured by a witness.*
