LANDING GEAR - LANDING GEAR WARNING HORN REPLACEMENT

425

441

CQB-32-01
Page 1 of 19

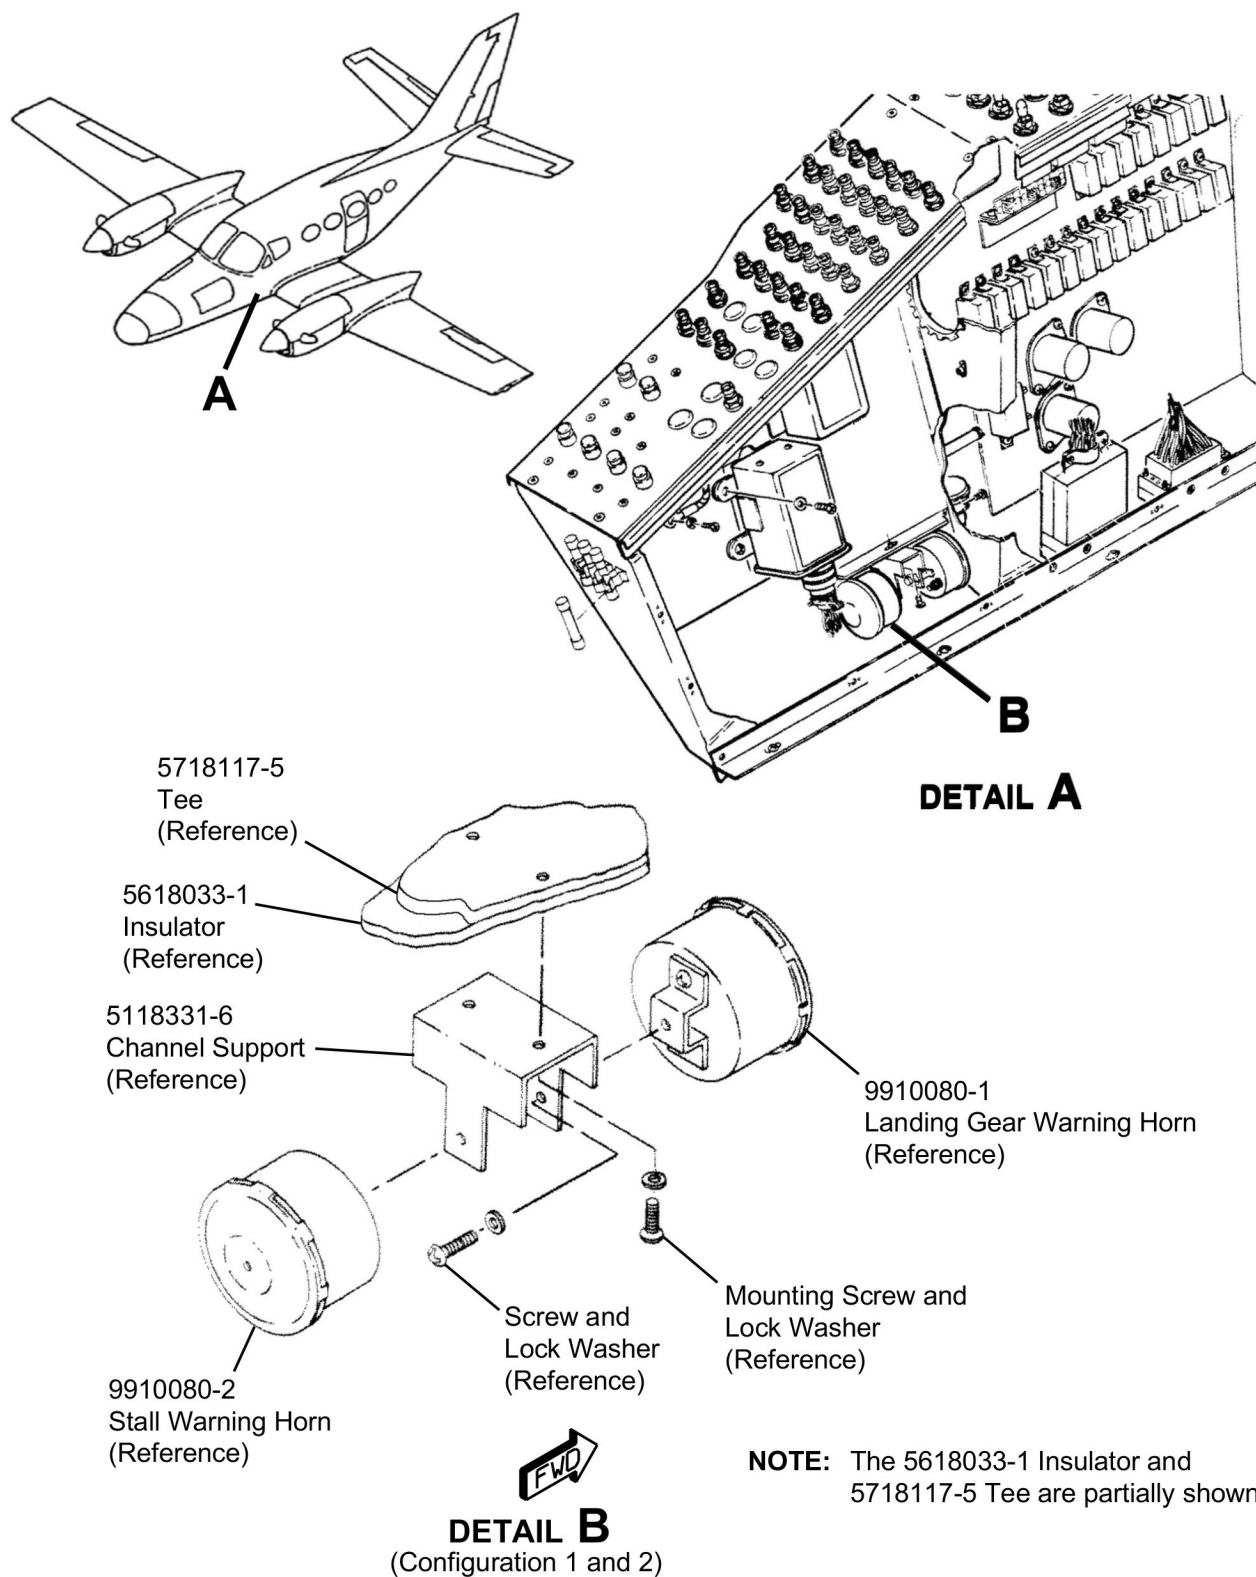
Figure 1. Before Modification (Sheet 1)

The original landing gear warning horn is no longer available. If the landing gear warning horn needs to be replaced, a new landing gear warning horn is available and will require an additional bracket for installation.

2. (Refer to Figure 1, Sheet 1.) Remove the 9910080-1 Landing Gear Warning Horn as follows:
 - A. Disconnect and label the electrical wiring from the 9910080-1 Landing Gear Warning Horn and the 9910080-2 Stall Warning Horn.
 - B. Remove the four rivets from the 5718117-5 Tee. (Refer to the applicable Maintenance Manual, Chapter 51, Fastener Installation and Removal.)
 - C. Remove and discard the screw, nut, and lock washer from the 9910080-1 Landing Gear Warning Horn.
 - D. Remove and discard the screw, nut, and lock washer from the 9910080-2 Stall Warning Horn.
 - E. Remove and keep the two mounting screws from the 5118331-6 Channel Support.
