NAVIGATION - STALL WARNING HORN REPLACEMENT FOR CESSNA MODELS 182, U206, 207

January 5, 2023

SEB-34-32
Page 1 of 9

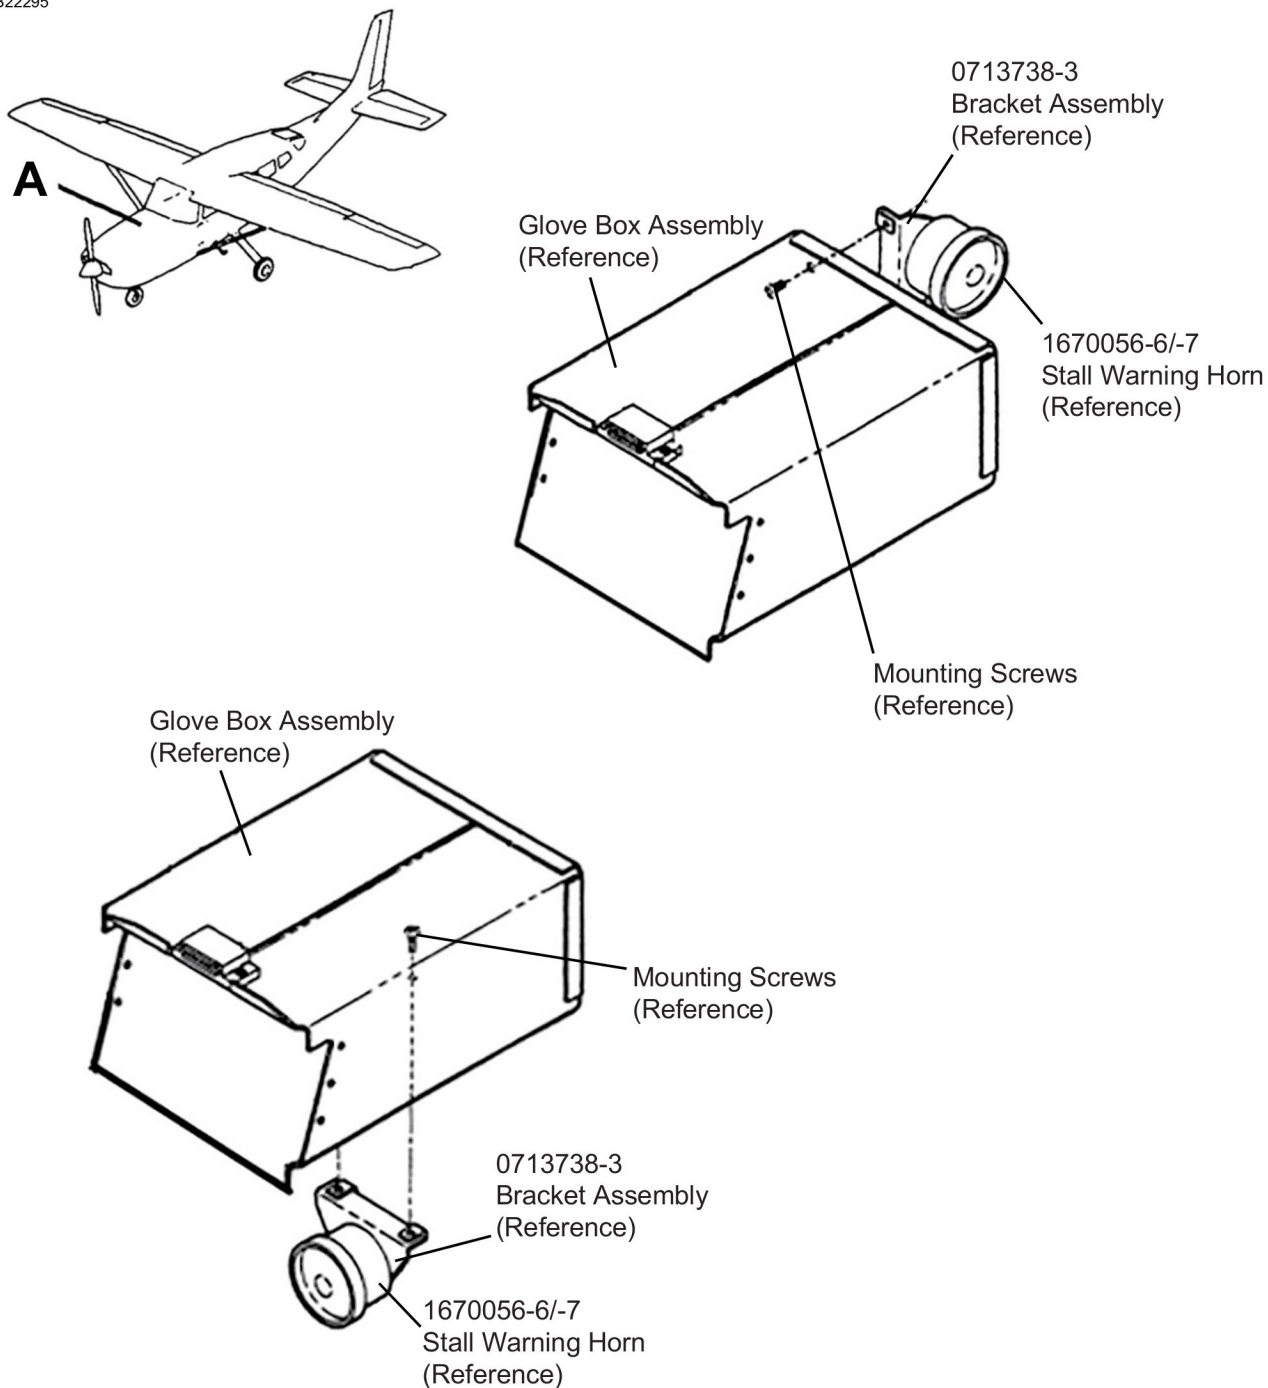
Figure 1. Before Modification (Sheet 1)

3. (Refer to Figure 1, Sheet 1.) Remove the 1670056-6/-7 Stall Warning Horn as follows:

NOTE: Depending upon the airplane model the 1670056-6/-7 Stall Warning Horn Assembly will be mounted on the bottom or forward side of the glovebox assembly. The removal and installation methods are the same for all models within this service document.

NOTE: There are two possible configurations for the 1670056-6/-7 Stall Warning Horn could be mounted on the glovebox assembly.

- A. Remove and keep the two mounting screws from the 1670056-6/-7 Stall Warning Horn.

- B. Remove the nuts and washers from the studs of the 1670056-6/-7 Stall Warning Horn.

- C. Disconnect the electrical wiring from the 1670056-6/-7 Stall Warning Horn.

- D. Discard the 1670056-6/-7 Stall Warning Horn and the 0713738-3 Bracket Assembly.

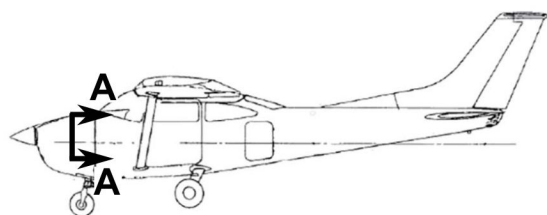
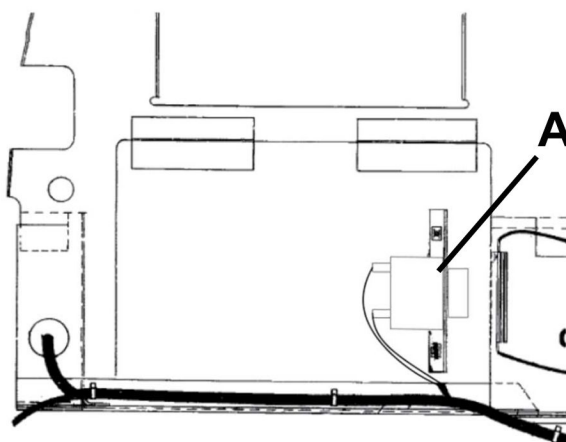
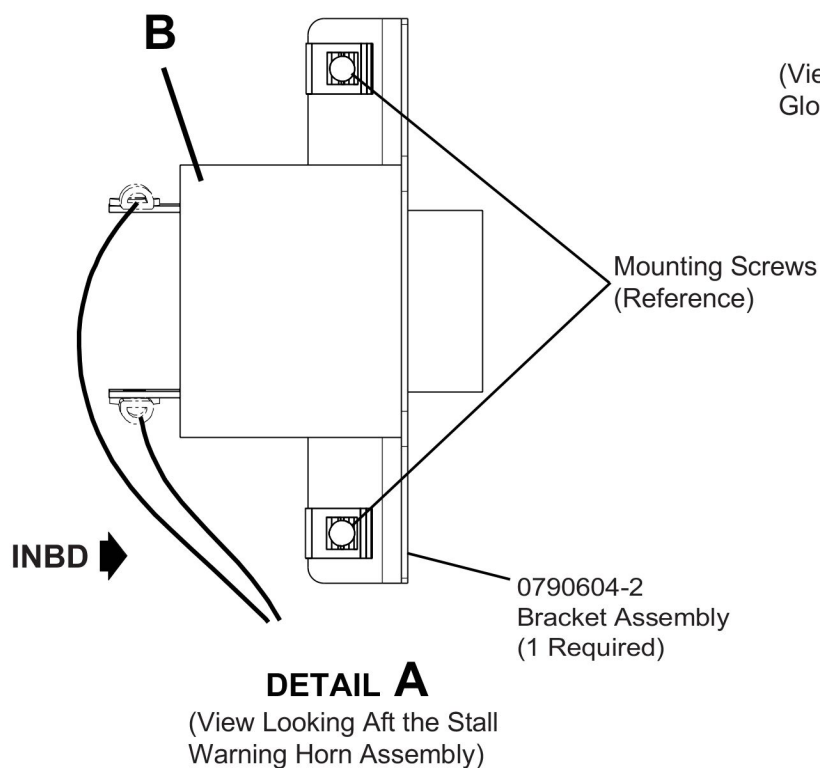
Figure 2. After Modification (Sheet 1)

NOTE: All installations of the 9910080-5 Stall Warning Horn will be mounted onto the forward side of the glovebox assembly.

4. (Refer to Figure 2, Sheets 1 and 2.) Install the 9910080-5 Stall Warning Horn as follows:

- C. Install the 9910080-5 Stall Warning Horn into the 0790604-2 Bracket Assembly.

- D. Install the knurled nut onto the 9910080-5 Landing Gear Warning Horn.

NOTE: The plastic knurled nut must be installed with the three indents toward the bracket and horn assembly. On the internal circumference, the smooth side without threads is installed first, towards the bracket and horn. This technique of installation will make sure the nut fully seats against the bracket and not bottom-out on the threads. If not installed correctly the knurled nut will bottom-out on the threads and the horn assembly will not be fully tightened in the bracket.

- E. Install the 0790604-2 Bracket Assembly with the two kept mounting screws onto the glovebox assembly.
- F. Install the electrical wiring with one MS35333-37 Lock Washer onto each terminal of the 9910080-5 Stall Warning Horn.
