NAVIGATION - STALL WARNING HORN REPLACEMENT FOR CESSNA MODELS 180, 185, 188

January 5, 2023

SEB-34-33
Page 1 of 11

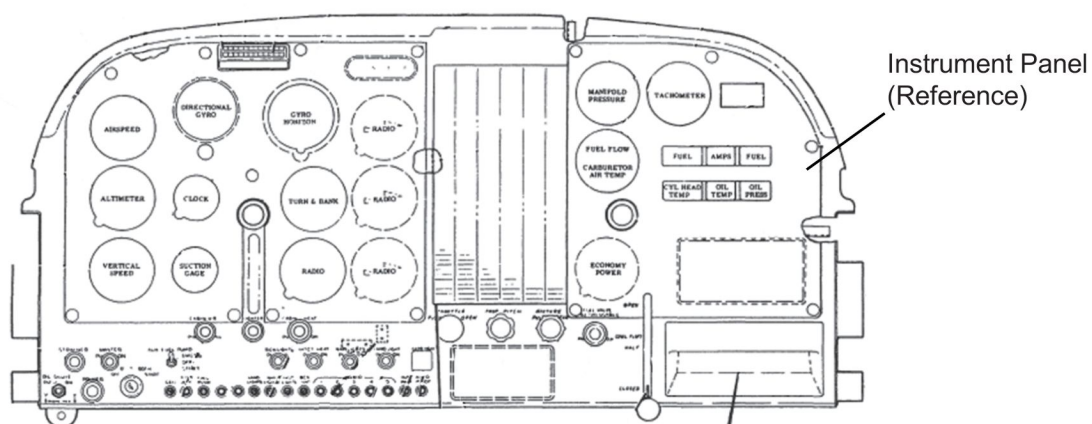
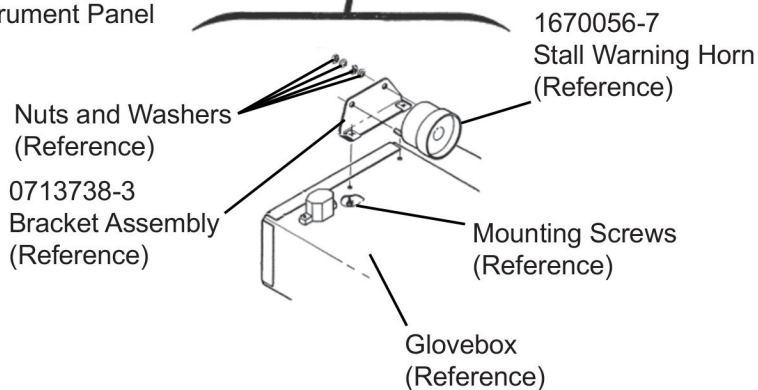
Figure 1. Cessna Model 180 and 185 Before Modification (Sheet 1)

3. (Refer to Figure 1, Sheet 1.) Remove the 1670056-7 Stall Warning Horn as follows:
- A. Remove the copilot seat.
B. Remove and keep the two mounting screws from the 1670056-7 Stall Warning Horn.
NOTE: The kept mounting screws will be used for installation.
C. Remove the nuts and washers from the studs of the 1670056-7 Stall Warning Horn.
D. Disconnect the electrical wiring from the 1670056-7 Stall Warning Horn.
E. Discard the 1670056-7 Stall Warning Horn and the 0713738-3 Bracket Assembly.

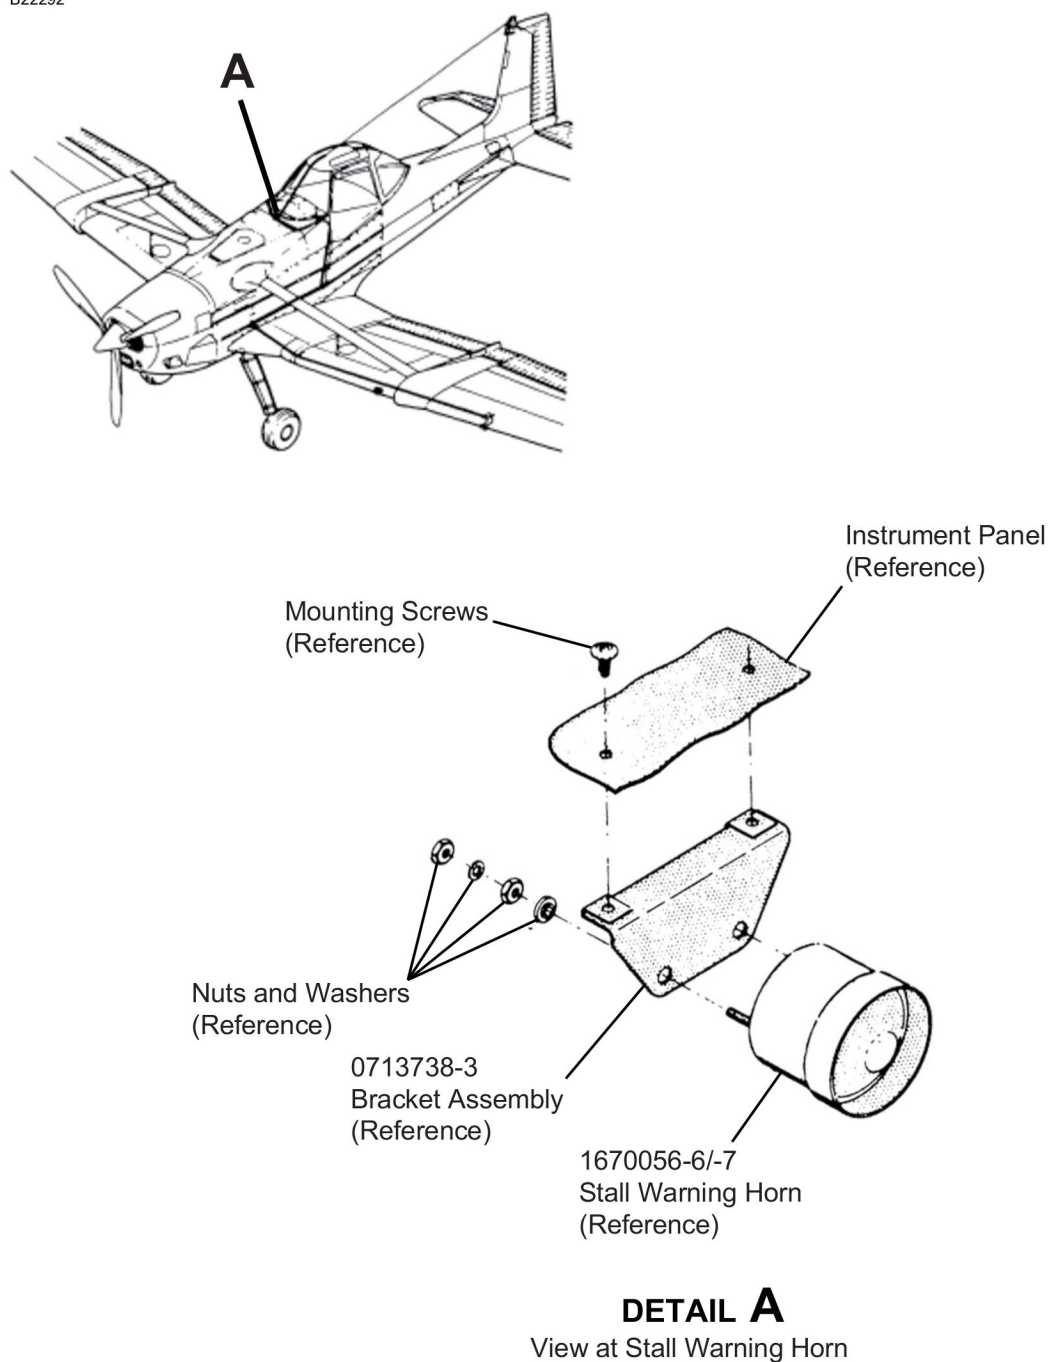
Figure 3. Cessna Model 188 Before Modification (Sheet 1)

NOTE: The Stall Warning Horn Assembly is located Forward of the Instrument Panel

5. (Refer to Figure 3, Sheet 1.) Remove the 1670056-6/-7 Stall Warning Horn as follows:
 - A. Remove the pilot seat and any additional interior as necessary.

- B. Remove and keep the two mounting screws from the 1670056-6/-7 Stall Warning Horn.
NOTE: The kept mounting screws will be used for installation.
 - C. Remove the nuts and washers from the studs of the 1670056-6/-7 Stall Warning Horn.

- D. Disconnect the electrical wiring from the 1670056-6/-7 Stall Warning Horn.
 - E. Discard the 1670056-6/-7 Stall Warning Horn and the 0713738-3 Bracket Assembly.
