SERVICE LETTER

POWER PLANT - TRANSMITTAL OF CONTINENTAL MOTORS MSB18-08C INSPECTION AND MAINTENANCE MODIFICATION OF CYLINDER ASSEMBLIES

SUBJECT:	Inspection and Maintenance Modification of Cylinder Assemblies
PURPOSE:	To inspect and remove casting material build-up on the radius edge of identified cross-flow cylinder heads.
COMPLIANCE:	If under 500 hours in service, perform radius blend inspection and modification no later than the next scheduled 100-Hour/Annual inspection. If 500 hours or greater, perform radius blend modification at the next maintenance event (not to exceed 50 hours).
MODELS AFFECTED:	New and rebuilt Continental Aerospace Technologies GTSIO-520-C, D, H, K, L, M, N; IO-550-G, N, P, R; IOF-550-N, P, R; TSIO-520-BE; TSIO-550-A, B, C, E, G, K, N and TSIOF-550-D, J, K, P aviation gasoline (AvGas) engines originally manufactured, rebuilt, or modified with a cross-flow cylinder replacement on or after 01 NOV 2014.

CATEGORY 1 **MSB18-08C**

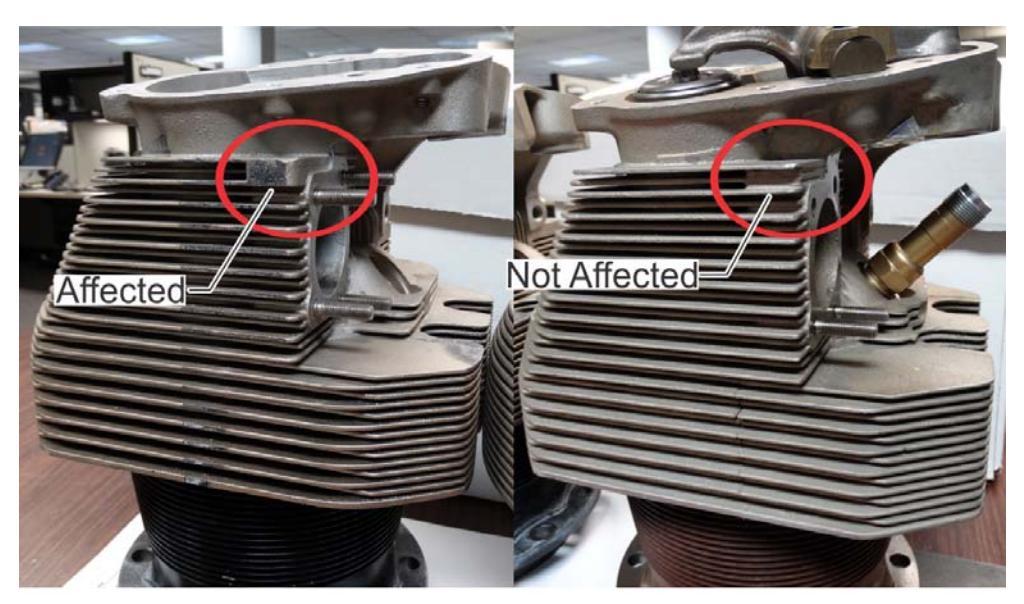
Several field reports indicate the potential for fracture initiation on engines (exceeding 500 hours of operation) at the radius edge of identified cylinder heads produced on or after 01 NOV 2014 (see Figure 3). The affected cylinder casting can be identified by the "filled" top fin flange area above the exhaust port as shown in Figure 1.

Affected cylinder head castings have a distinguishing feature (see Figure 1) from unaffected. Affected new and rebuilt engines with serial number 1036883 and later were inspected and corrected at the factory to comply with this Service Document.

Figure 1. Affected Cross Flow Cylinders, Top Fin Flange typical

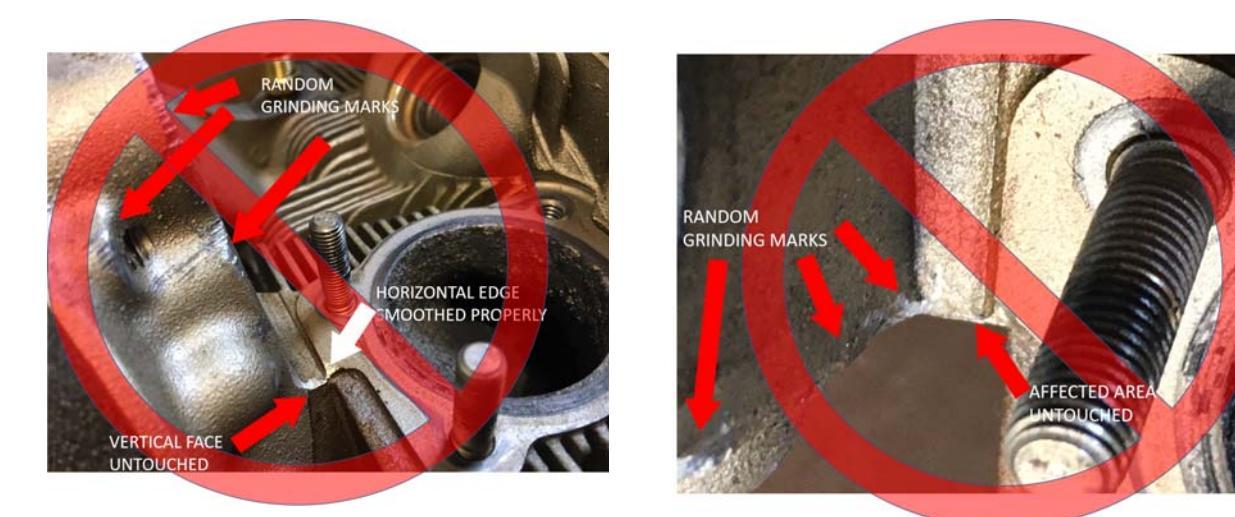
B. Exhibits of Failed Compliance Attempts

Examples in this section illustrate unacceptable attempts to perform the modifications intended to meet the requirements. The preferred tool to accomplish the modification is a short (6" to 8") bastard file; it is very effective for smoothing the affected outside corner and is easier to control in tight spaces than a power tool, such as a die grinder.

Incomplete Rework with Grinding Marks on Unaffected Area Grinding Marks Evident but Affected Area Untouched

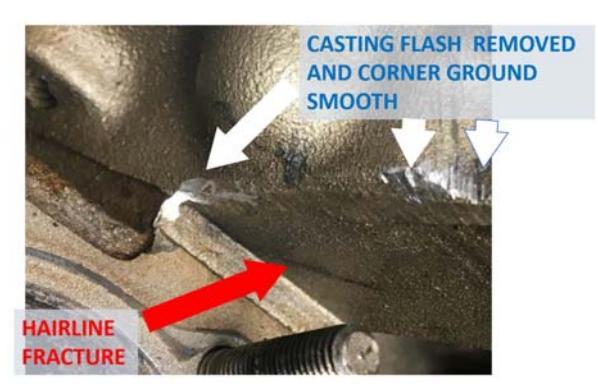
The photos below are from a cylinder removed for oil seepage at 802 hours. The log book entry for compliance with SB18-08 was 798 hours. The red arrow in the photo points to the hairline fracture already existing in the affected inspection area at the time compliance was recorded.

Rework performed on cracked cylinder

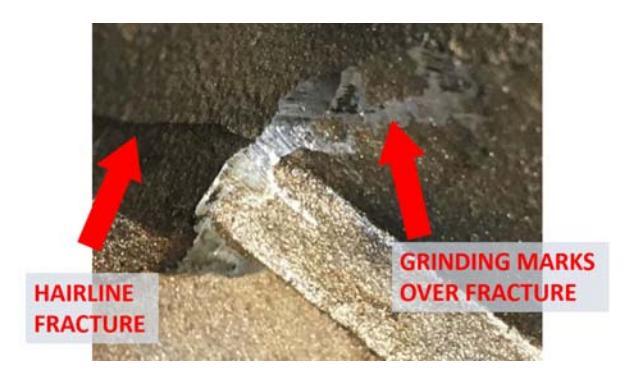
grinding marks through crack - closeup

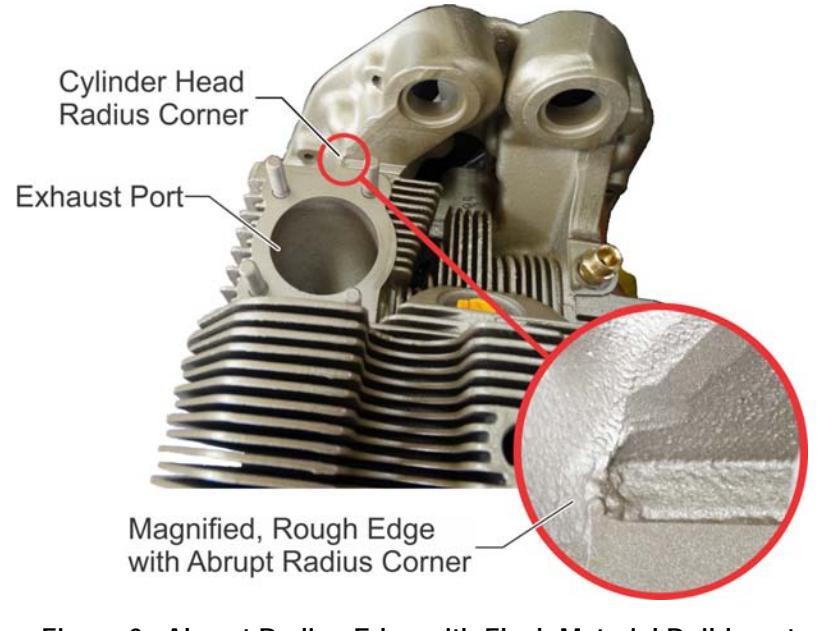
Figure 3. Abrupt Radius Edge with Flash Material Build-up, typical

2. **RC** Use an inspection mirror to visually inspect the radius corner angle below the exhaust port (see Figure 6) for any casting flash build-up or sharp radius edges. The radius corner should be tapered and blended smooth (reference Figure 5).

4. **RC** Remove built-up flash material using a 1/4" round (rat tail) metal file (i.e. Lima Redonda (Matco Tools Catalog No. MT2219-3) (Figure 8)), or equivalent) held at an approximate 30 degree angle (see Figure 10). The hand file is the preferred method of blending the required radius and is easier to manipulate than a power too, such as a pencil grinder, in tight spaces.

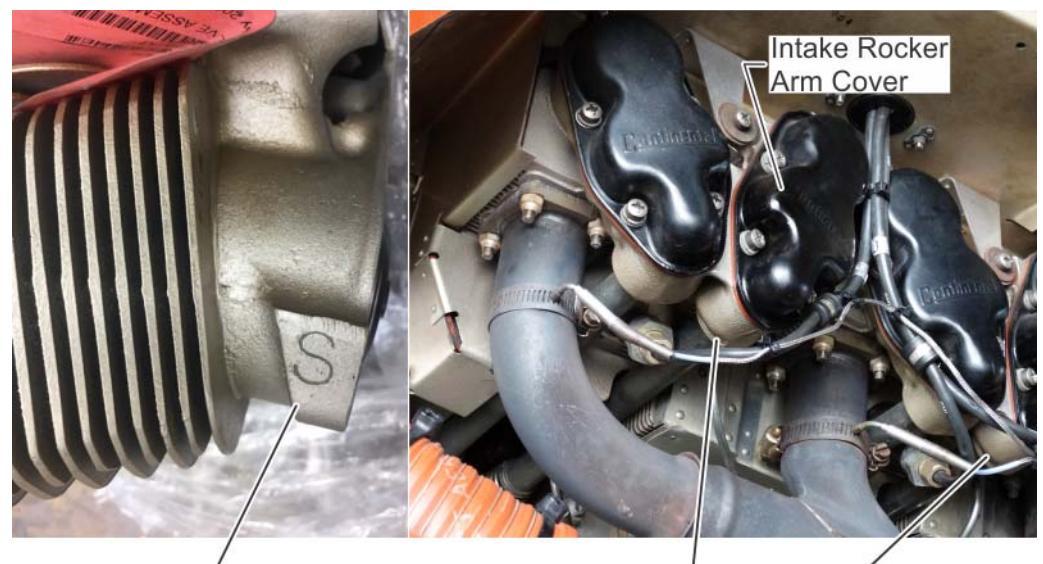
- 1. The cylinder head meets compliance with Service Document (MSB18-08) if:
 - a. Serial number AC18KB277 or later (reference Figure 12), or if
 - b. The letter "S" is metal stamped on either the cylinder head exhaust ear or on the exposed face of the intake pushrod boss, (reference Figure 4), *and if*
 - c. The radius corner inspection and modifications were completed in accordance with this Service Document (reference Figure 5).

Cylinder Head Exhaust Ear Exposed Face of Intake Pushrod Boss Figure 4. Cylinder Head Indicates Prior Compliance, Stamped with Letter "S"

- 8. Metal stamp the letter "S" (1/4" stamp) on the face of the intake pushrod boss (reference Figure 4) to indicate service document compliance.
- 9. Create a logbook entry detailing the compliance action taken in accordance with this Service Document (MSB18-08C). The logbook entry must record all cylinder head serial numbers and include a complete listing of parts used in this installation.

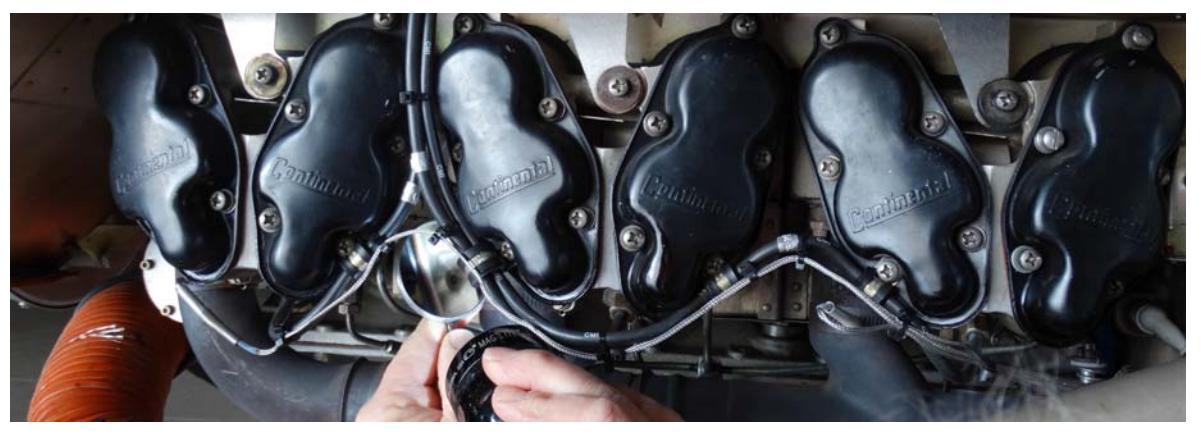
Figure 6. Cylinder Head Inspection Area, typical aircraft installation

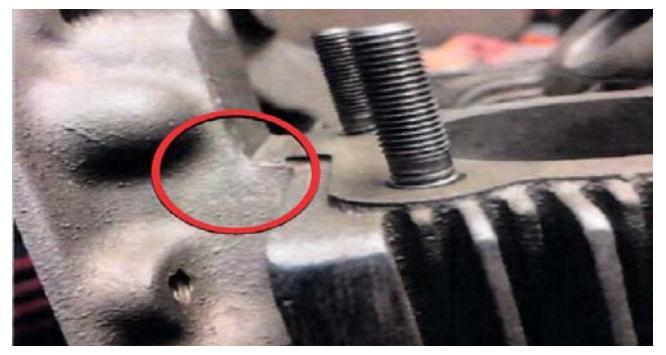
3. **RC** Perform a "Non-Destructive Visual Inspection" according to the latest instructions in M-0, Standard Practice Maintenance Manual, Chapter 11, on the area surrounding the cylinder head radius corner (all possible angles). To thoroughly inspect all areas of the cylinder without disassembly, use a magnifying inspection mirror and light source or a borescope with magnification. All cracks require attention, regardless of size or location. If a fissure, crack or physical damage is identified, replace the cylinder.

Figure 7. Cylinder Head Radius Corner, side view *CAUTION: Wear eye protection to avoid injury from flying debris.*

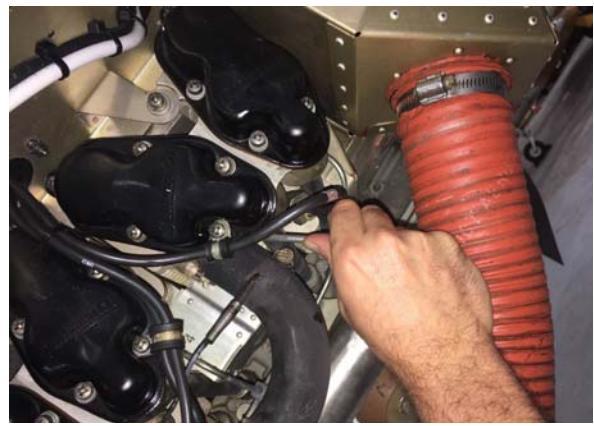
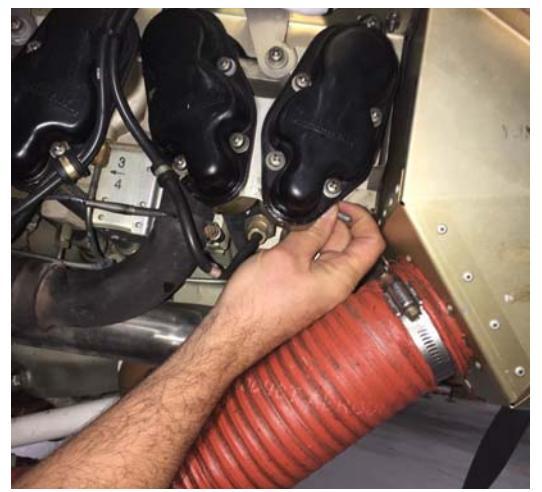
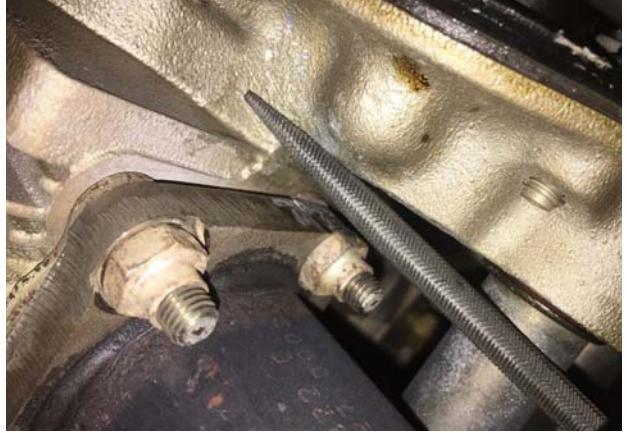
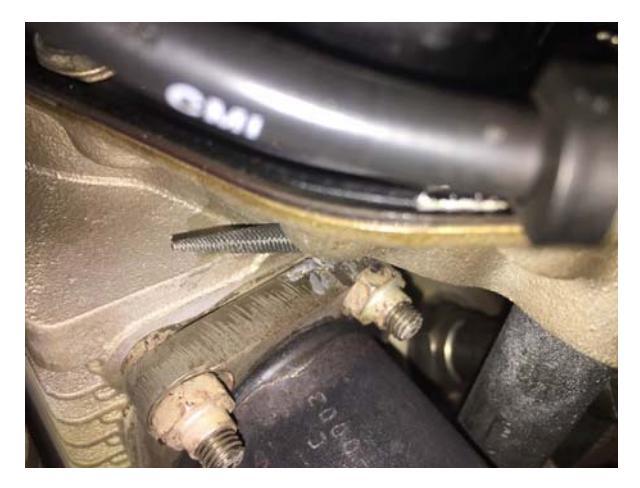
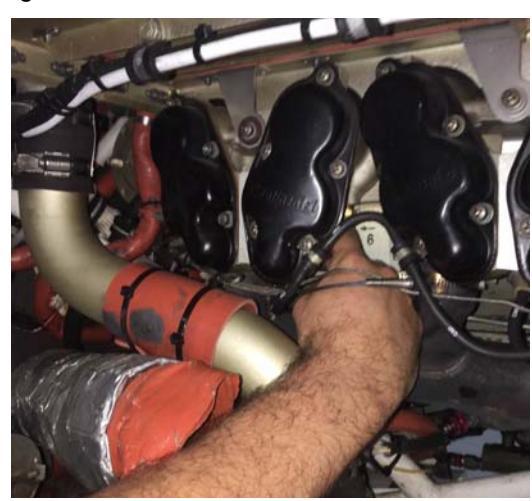
Hand placement for working horizontal edge Figure 9. Reworking Cylinder Head Corner on Aircraft

- a. Carefully, sweep the file around the outside corner to obtain a smooth, blended radius edge.
- b. Remove <u>ONLY</u> enough material from the cylinder head to blend the radius, see Figure 5 and Figure 10. A smooth blend should remove no more than 0.20" material.

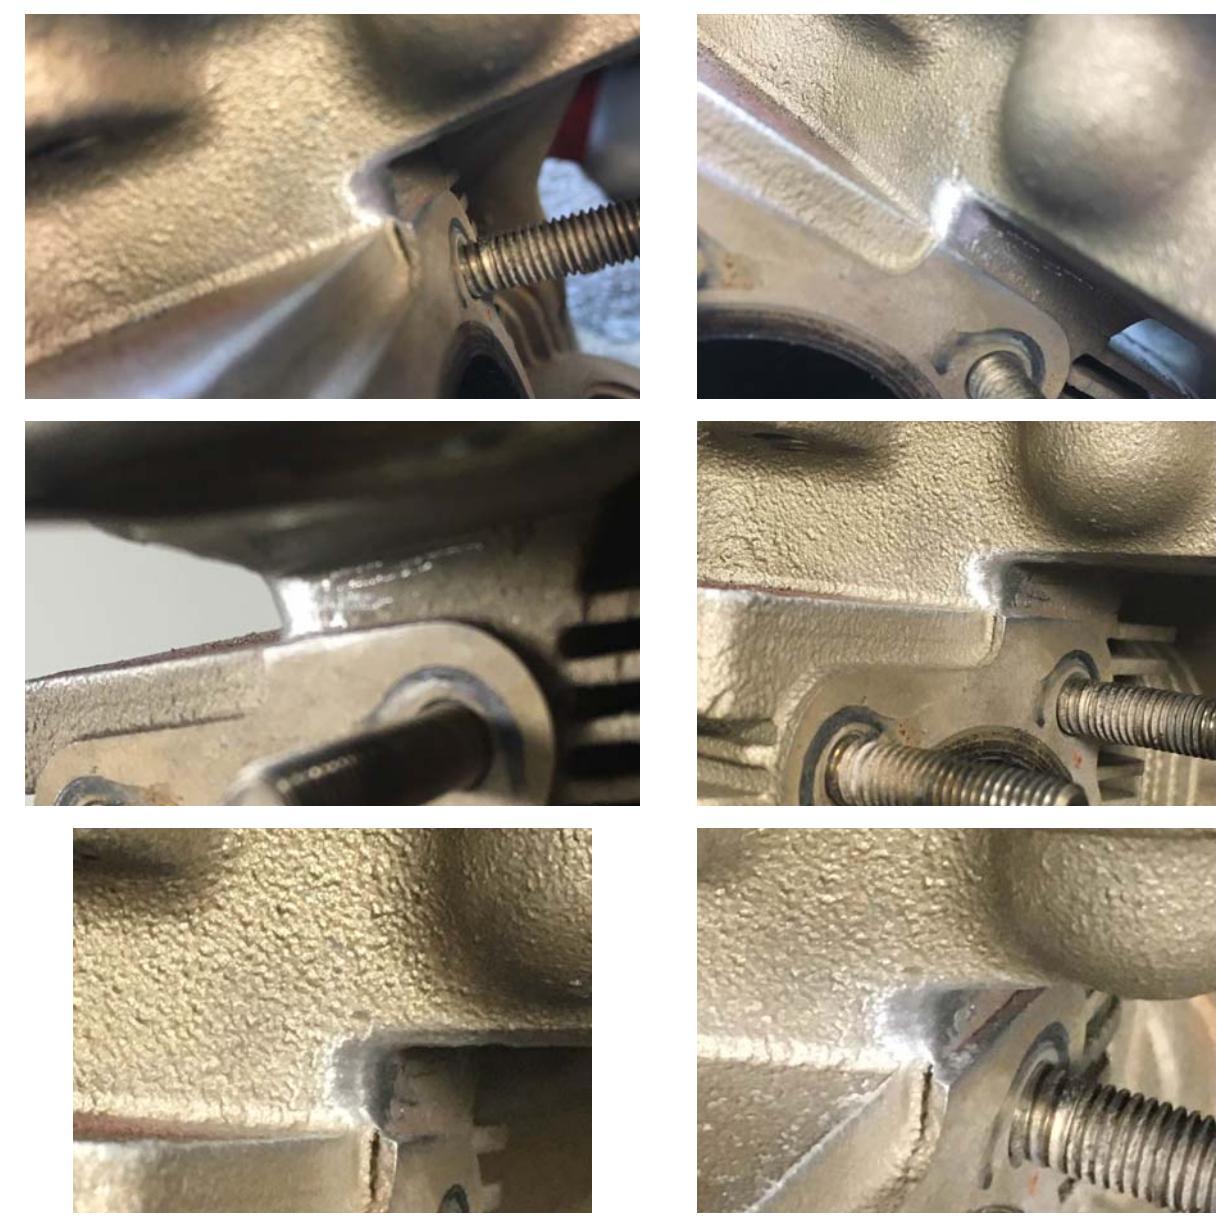
c. Photographs in Figure 10 are examples of the smoothing operation correctly executed. The exhaust system and the pushrod tubes are removed for clarity only. Engine disassembly is NOT required to comply with the instructions in this service document.

Figure 10. Smoothed Radius Corner after Blending

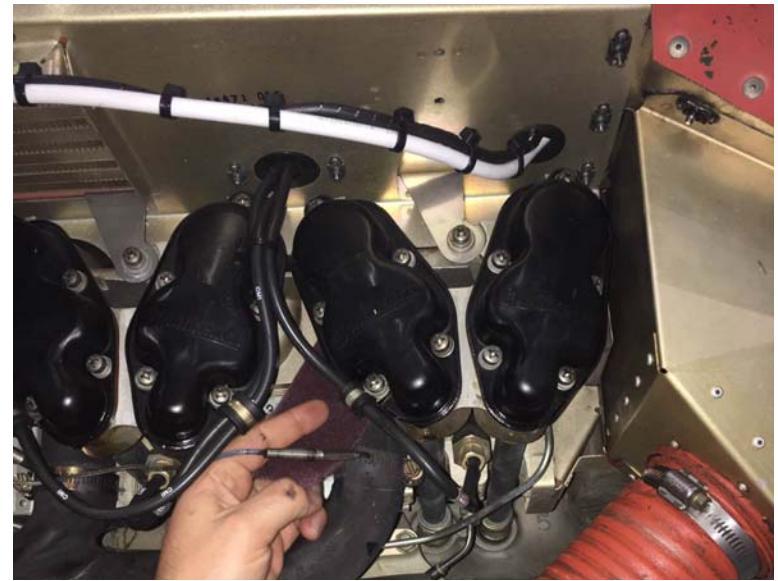
Figure 11. Deburring with Scotch-Brite[™] Pad

5. **RC** Inspect the cylinder head surface and remove all nicks, burrs, sharp angles or edges using a de-burring tool and Scotch-BriteTM (ultra fine or equivalent) pad. Evenly shape, taper, and smooth all interfering surfaces where material was removed (see Figure 5).
