MANDATORY**SEL-55-01****TITLE**

STABILIZERS - TAILCONE AND HORIZONTAL STABILIZER INSPECTION

SEL-55-01
Page 1 of 9

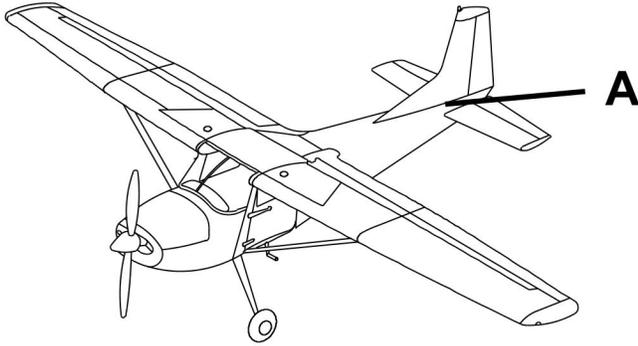
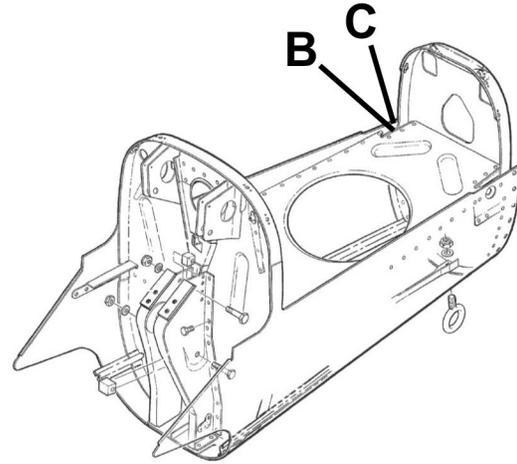
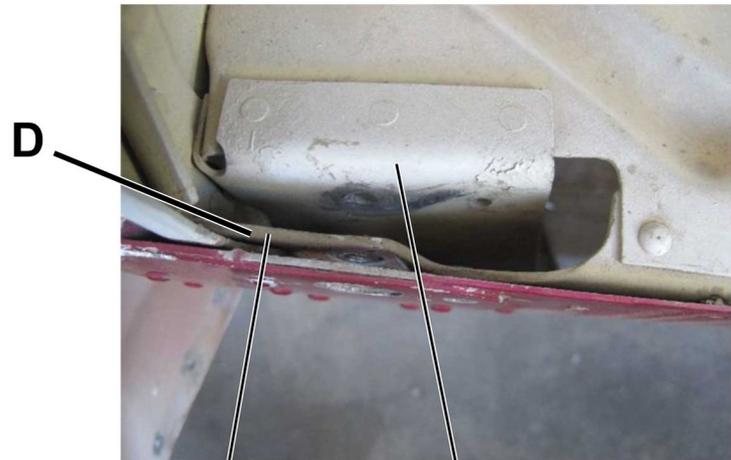
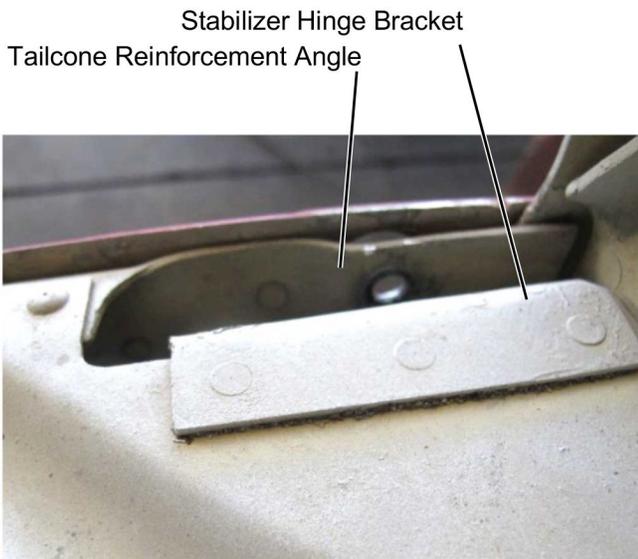
Figure 1. Tailcone Inspection (Sheet 1)

DETAIL A

DETAIL B
Looking Down, Inboard
Right Side Shown,
Left Side Opposite

DETAIL C

Looking Down, Outboard
Right Side Shown, Left Side Opposite

7. (Refer to Figure 1 Detail A and Figure 2 Detail B.) Remove attaching hardware at the stabilizer hinge assemblies and stabilizer hinge brackets.
 - For Models 180, 182 and 185 (1953-1968) refer to Section 4, Airframe - Horizontal Stabilizer.

9. (Refer to Figures 1 and 2.) Clean the following areas to be inspected (Refer to Section 2, *Ground Handling, Servicing, Cleaning, Lubrication and Inspection - Cleaning* in the applicable model maintenance manual.):

11. (Refer to Figures 1 and 2.) Do a detailed inspection of the following areas (Refer to Section 2A, *Supplemental Inspection Documents - Nondestructive Inspection Methods and Requirements - Visual Inspections* in the applicable model maintenance manual.):

15. (Refer to Figure 1 Detail A and Figure 2 Detail B.) Install attaching hardware at the stabilizer hinge assemblies and stabilizer hinge brackets.

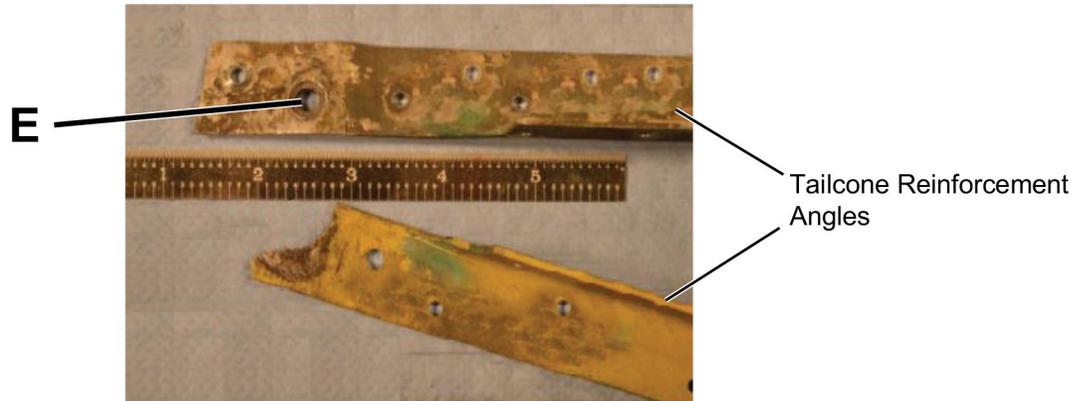
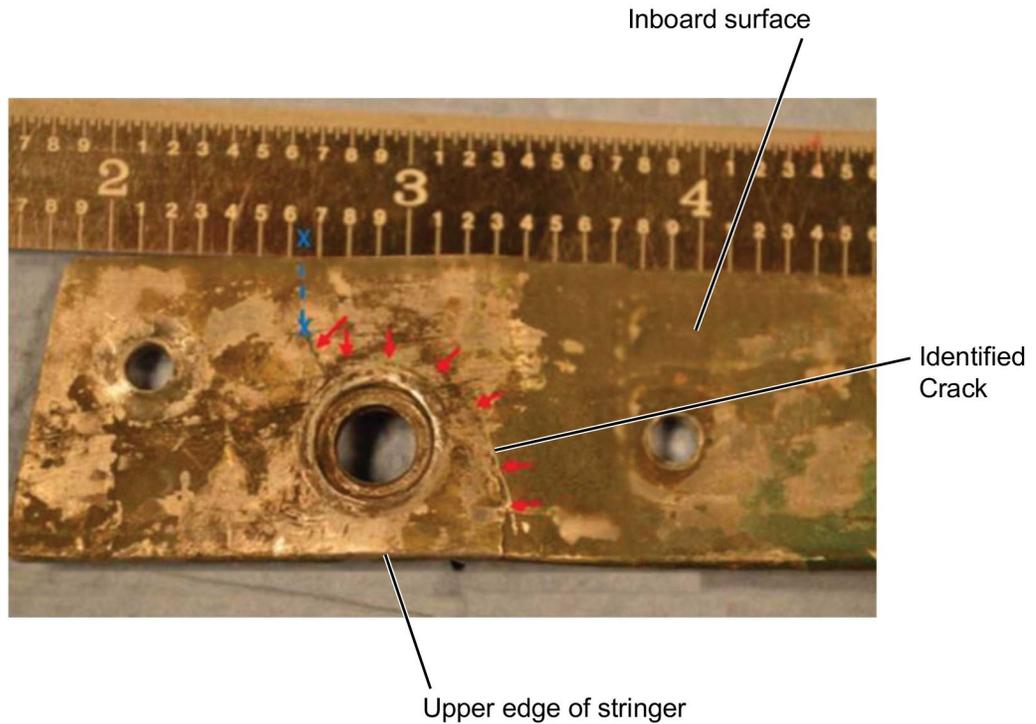
Figure 1. Tailcone Inspection (Sheet 2)

DETAIL D

Parts Shown Removed From Tailcone

DETAIL E

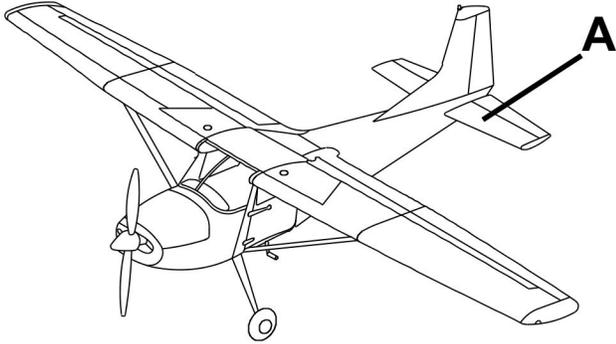
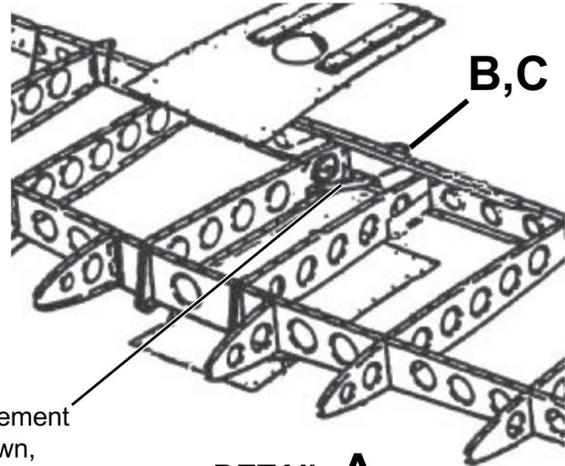
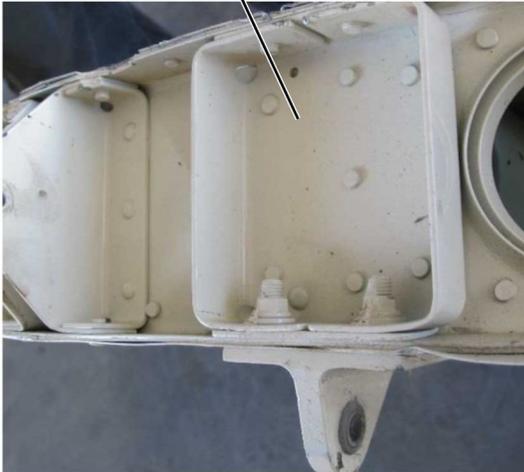
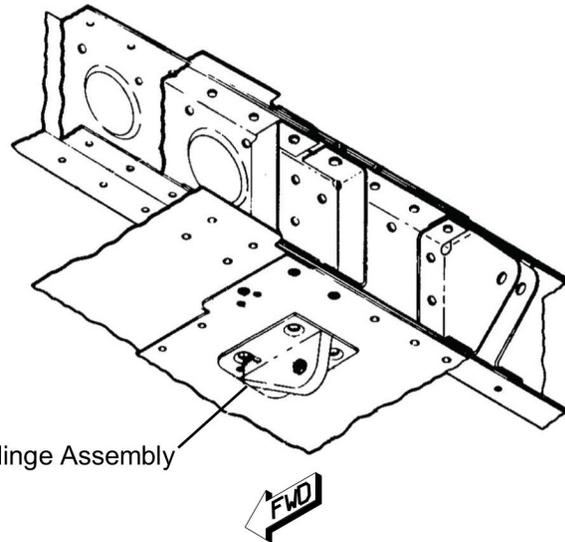
Figure 2. Horizontal Stabilizer Inspection (Sheet 1)

Corner Reinforcement
(Right Side Shown,
Left Side Opposite)

DETAIL A

Looking Aft Skin Has Been
Removed For Clarity

Stabilizer Hinge
Reinforcement
Channel

DETAIL C

Looking Forward
Right Side Shown,
Left Side Opposite

DETAIL B

Looking Up and Forward
Left Side Shown,
Right Side Opposite

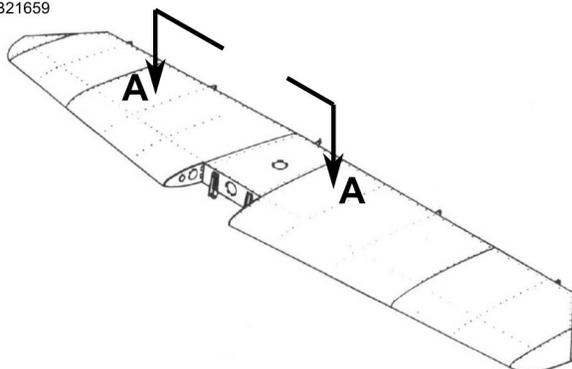
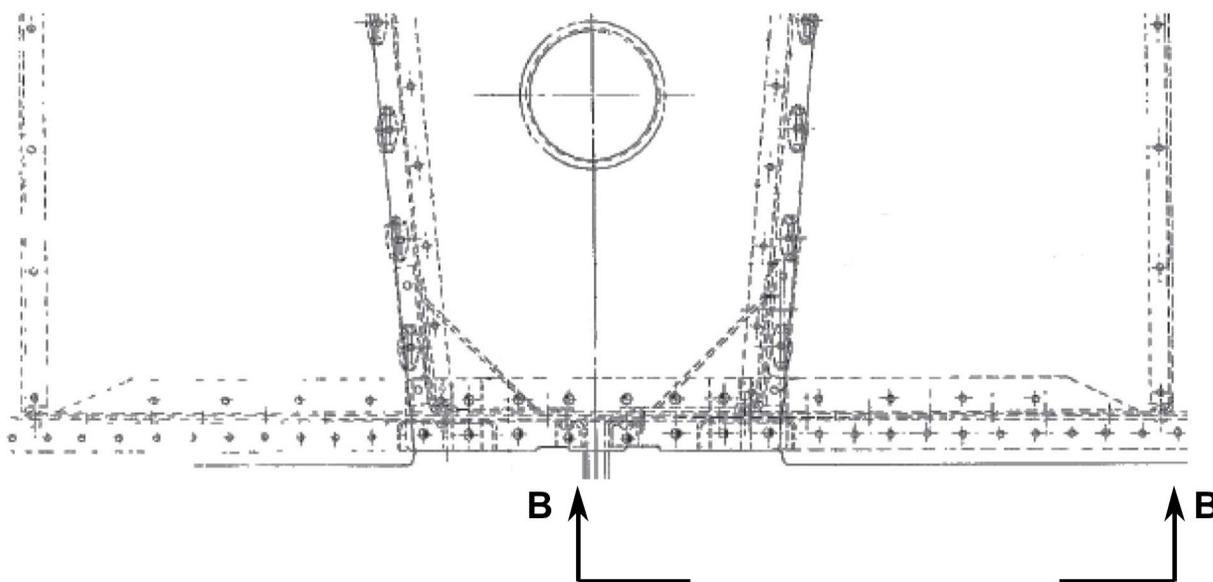
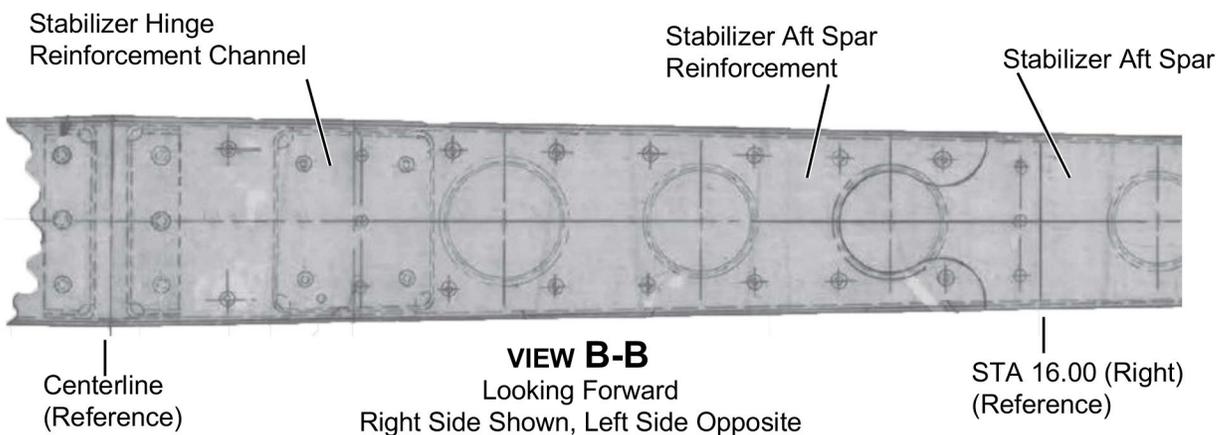
Figure 2. Horizontal Stabilizer Inspection (Sheet 2)

VIEW A-A
Horizontal Stabilizer
Looking down

VIEW B-B
Looking Forward
Right Side Shown, Left Side Opposite
