SERVICE LETTER

MANDATORY MEL-79-01

OIL - TRANSMITTAL OF CONTINENTAL AEROSPACE TECHNOLOGIES CSB07-1A CONNECTING ROD PISTON PIN BUSHING INSPECTION

SUBJECT: Connecting Rod Piston Pin Bushing Inspection

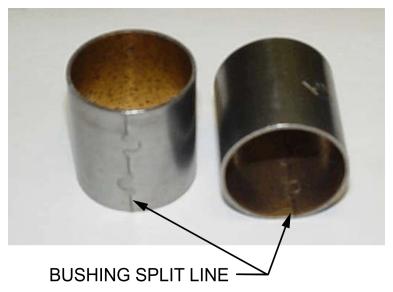
Figure 1. Typical New Piston Pin Bushings

Continental Aerospace Technologies, Inc. (ContinentalTM) has received reports from the field of piston pin bushing material being found in the oil sump or the oil filter. Piston pin bushings are manufactured from steel-backed bronze and are curved on a radius of approximately 0.62" (see Figure 1).
