# National Transportation Safety Board Aviation Accident Preliminary Report

<b>Location:</b>	Danville, VA	<b>Accident Number:</b>	ERA22FA114
<b>Date &amp; Time:</b>	February 1, 2022, 10:06 Local	<b>Registration:</b>	N622QT
<b>Aircraft:</b>	Cessna 310	<b>Injuries:</b>	1 Fatal
<b>Flight Conducted Under:</b>	Part 91: General aviation - Aerial observation

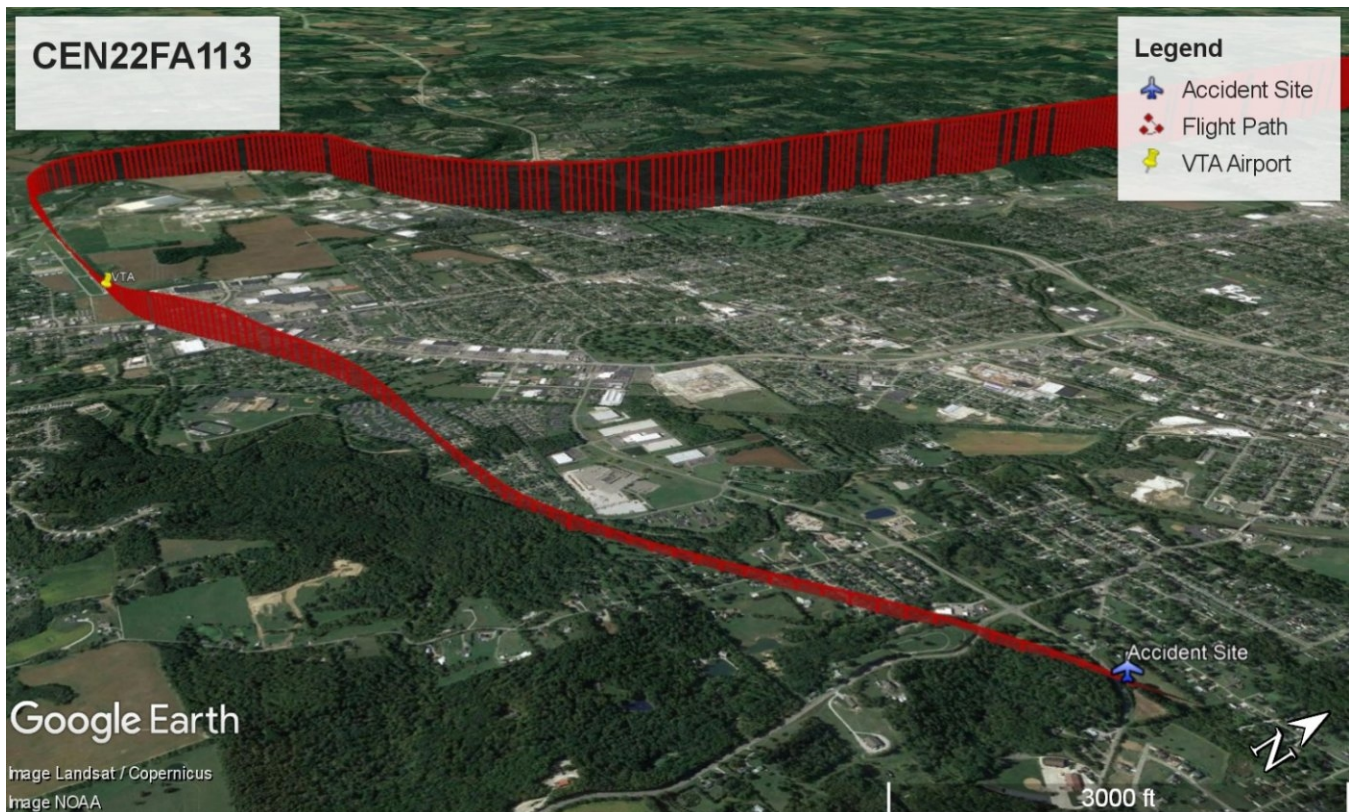
Figure 1. End of Flight Path

At 1338, the pilot completed a touch-and-go landing at Newark-Heath Airport (VTA), Newark, Ohio, then departed to the east. The airplane climbed to about 500 ft above ground level (agl), then descended to 85 ft agl over a residential area. During the last 30 seconds of the flight, the airplane flew about 100 ft agl and about 145 kts groundspeed before it descended into trees. Figure 1 shows the end of the flight path overlaid onto Google Earth.

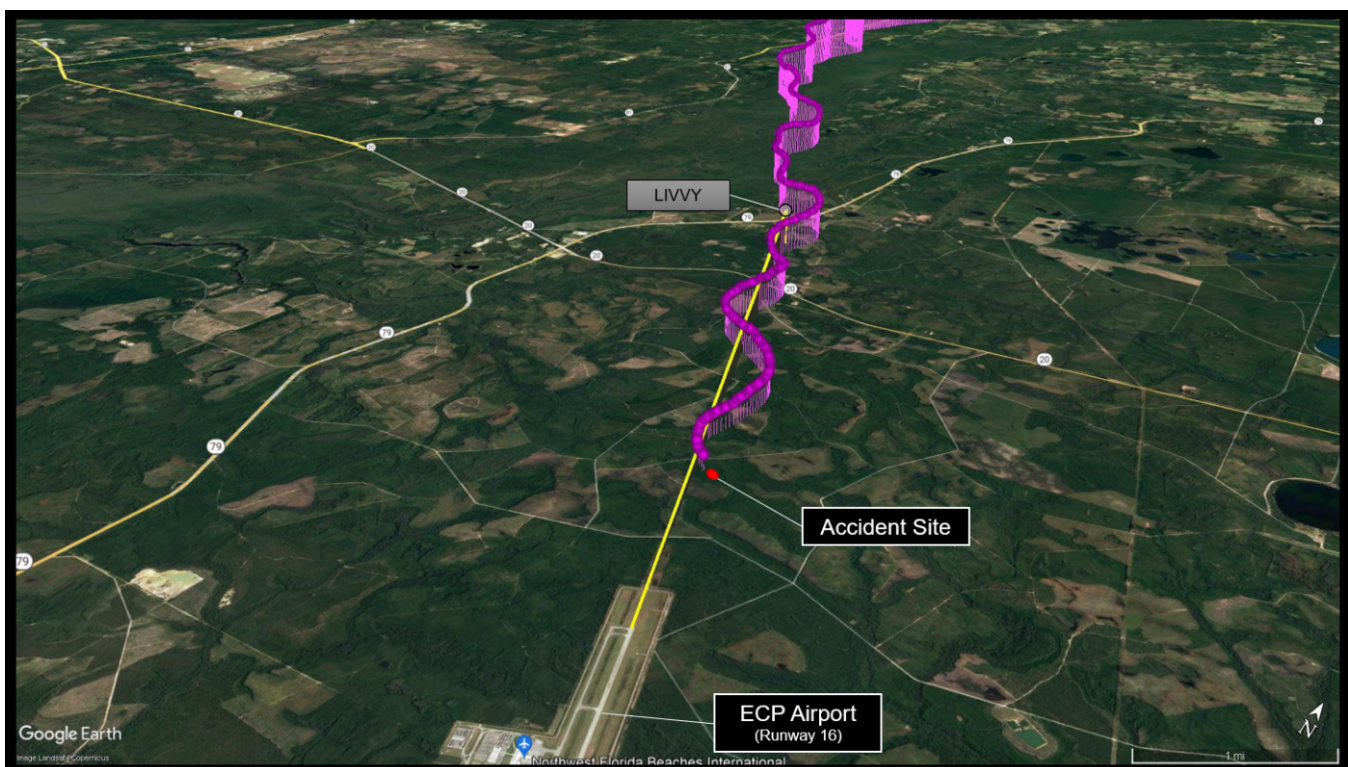
Figure 1: Overview of the flight track, final approach course, and accident site.

Review of the ADS-B flight track in the final approach phase found that the airplane’s course deviated left and right from the initial approach fix to the accident site, which was 1.55 nautical miles from the runway threshold. The airplane’s altitude showed momentary descents and climbs while on final approach. The final ADS-B data point recorded the airplane at 75 ft mean seal level, 144 knots groundspeed, with a ground track heading of 130°. Figure 1 shows the accident site, the final approach course represented as the yellow line, and the airplane’s flight track represented in the magenta line.

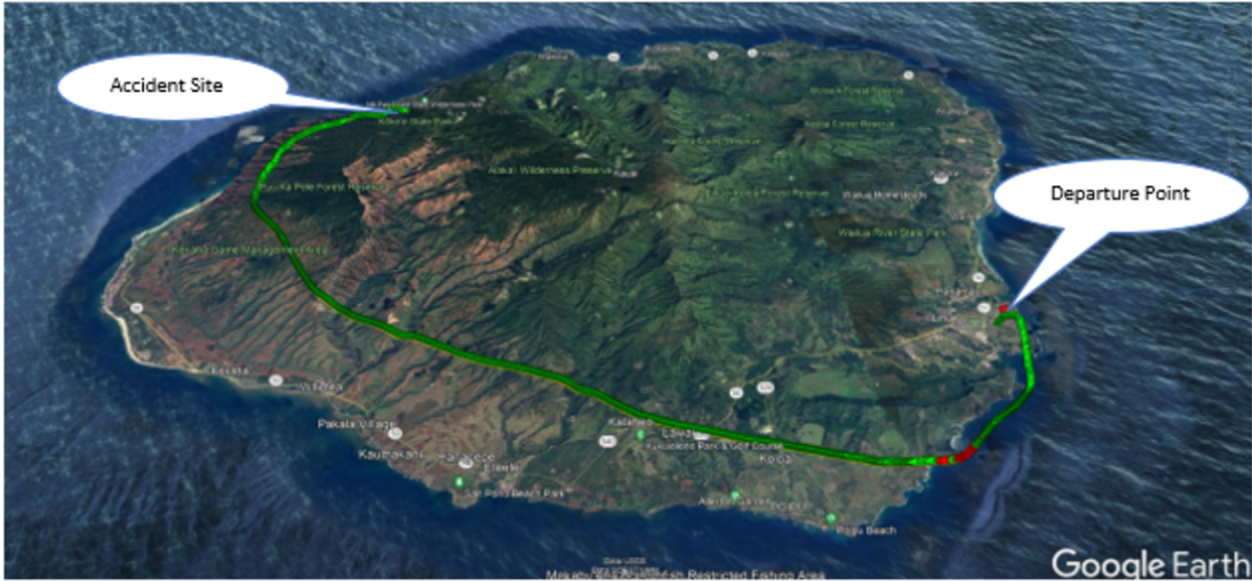
Figure. ADS-B track data for N98763 which depicts the departure, flight path, and accident site.

According to archived Federal Aviation Administration ADS-B data, after the airplane departed the Lihue Airport, it initially proceeded southwest, then it turned north as it neared the northwest side of the island. The airplane then turns to an easterly heading, towards an area of rising terrain. The ADS-B data stops near where the wreckage was found.

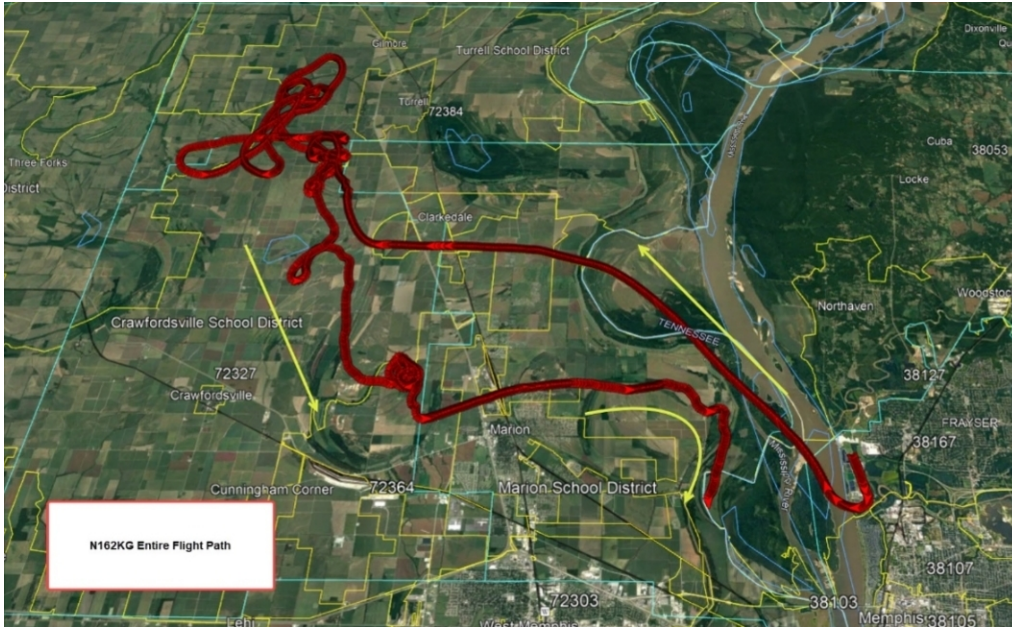
*Figure 1 – Plot of Airplane Position Data*

At 0826, the pilot contacted Memphis approach and informed the controller that he was experiencing chest pains. The airplane was about 9 miles west of M01 at that time. The pilot subsequently established the airplane on an easterly course toward M01. However, at 0833, the flight track turned southbound, and the airplane entered a descent and impacted terrain.

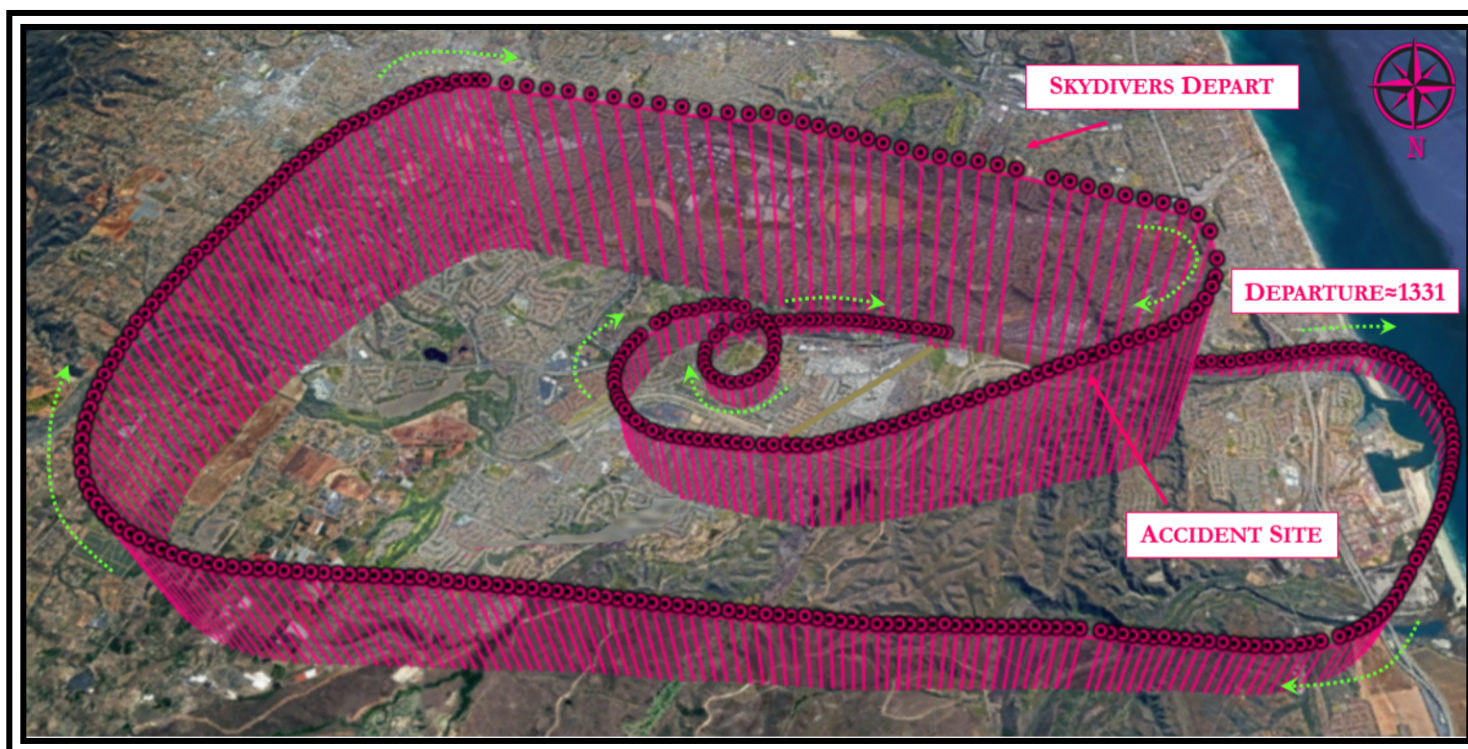
Figure 1: Flight Profile from ADS-B

After departing from runway 25, the airplane made a gradual climb to 11,575 ft msl as it circled to the right, back to the airport. The airspeed was reduced (presumably to unload the skydivers) and then the airplane made a steep, turning decent reaching 133 kts when transitioning to the downwind leg of the traffic pattern. The airplane was at an altitude of about 2,400 ft msl and 2.6 nautical miles (nm) from the approach end of runway 25 when it turned onto final approach. When the airplane was about 2 nm from the runway, it made a 360° right-turn which was about 0.5 nm in diameter (see Figure 1 below).

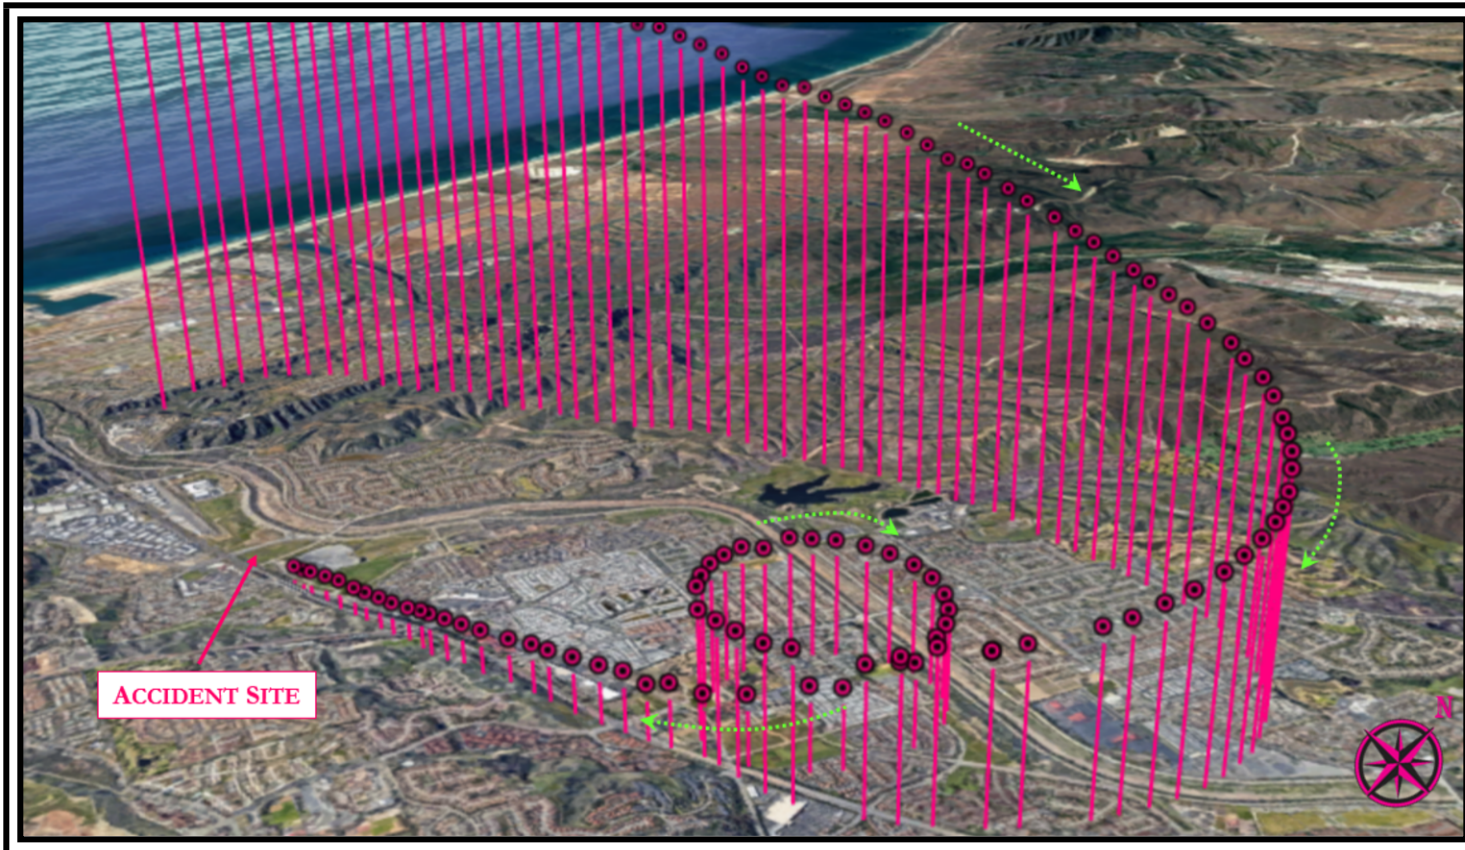
Figure 2: Final Approach Path (showing altitude)

At 1346:10, about 1,025 ft msl, the airplane rolled out of the 360° turn and continued west toward the runway. The airplane was roughly following Highway 76 making a gradual descent (see Figure 2 below). About 33 seconds later the airplane's speed dropped to 92 kts as it passed through 500 ft msl. The last recorded hit was at 1347:10 and located about 975 feet east of the accident site. At that time, the data indicated that the airplane was at 100 msl (equivalent to 60 feet above ground level) at a speed of 68 kts. Witness stated that they observed the airplane flying at a very low altitude (see Figure 3). The airplane then pitched down in a nose-low attitude and bank to the right. The airplane impacted terrain and collided with the side of a berm.

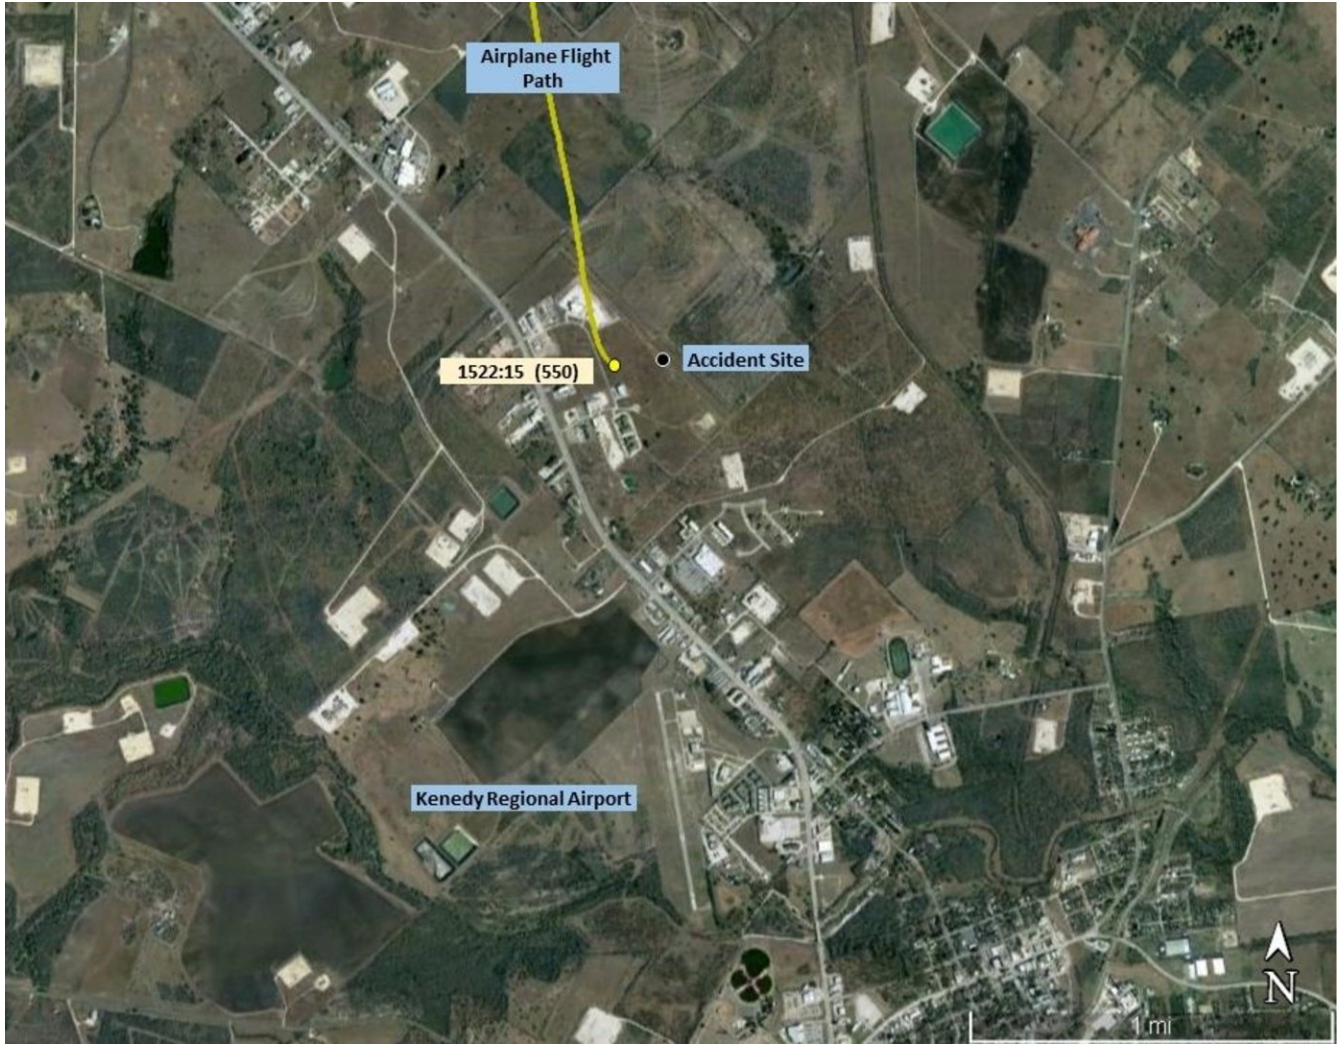
Figure 1 – Plot of Airplane Position Data (Final Approach Segment)

Automatic Dependent Surveillance – Broadcast (ADS-B) data revealed that the flight departed the New Braunfels National Airport (BAZ), at 1452 and proceeded southbound toward Kenedy Regional Airport (2R9), Kenedy, Texas. The airplane briefly reached an altitude of 6,300 ft mean sea level (msl) before descending to 5,600 ft msl. About 1508, while the airplane was about 23 miles north of 2R9, the pilot initiated a descent that continued until the final data point. About 1516, the pilot appeared to alter course slightly to align with the extended centerline for runway 16 at 2R9. About 3 seconds before the final data point, the flight track depicted the airplane entering a gradual left turn, as shown in figure 1. The final data point was recorded at 1522:15 with a corresponding altitude of 550 ft msl.

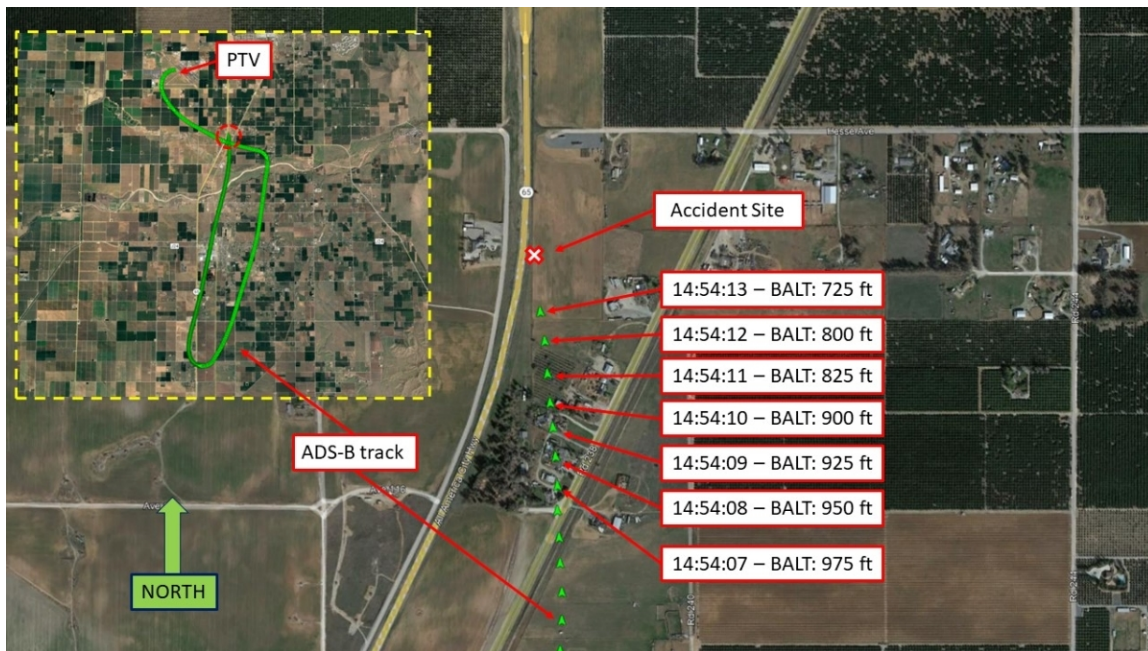
Figure 1: Recorded ADS-B Data plots.

Recorded Automatic Dependent Surveillance Broadcast (ADS-B) data, depicted in figure 1, showed the airplane in a left climbing turn shortly after takeoff from runway 30 at Porterville Municipal Airport (PTV). The airplane climbed to about 825 ft msl on a southeasterly heading. About 1 minute 7 seconds later, the airplane initiated a right turn to a southerly heading. The airplane continued a south-southwesterly heading for about 2 minutes, 46 seconds, and ascended to about 1,550 ft msl before a descending right turn to a northerly heading. About 37 seconds later, the airplane leveled off about 1,000 ft msl and continued north for about 1 minute, 41 seconds. The last 6 seconds of recorded data showed the airplane in a descent from 975 ft to 725 ft near the last recorded ADS-B target, which was located about 435 ft south of the accident site.

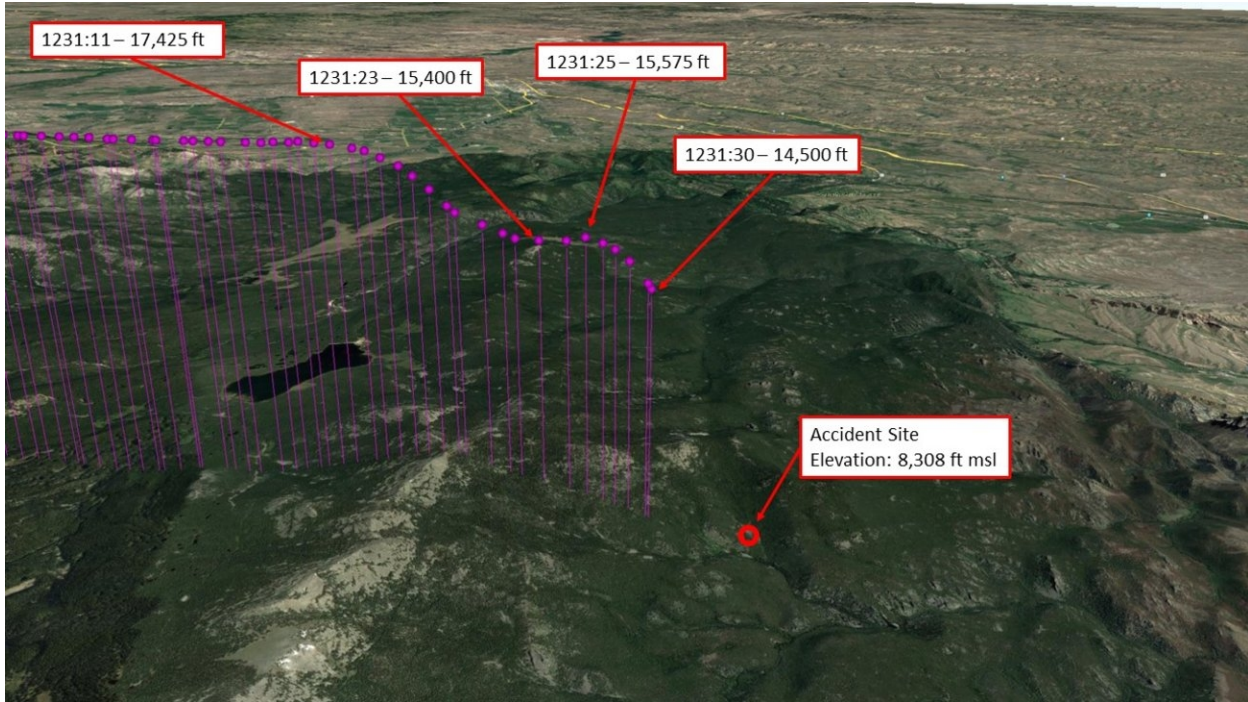
Figure 1: Plotted ADS-B Data

Recorded Automatic Dependent Surveillance Broadcast (ADS-B) data showed the airplane departed from Powell Municipal Airport, (POY) Powell, Wyoming, and progressed along a southeasterly course, while it ascended to 17,450 ft mean sea level (msl). The airplane remained at that altitude for about 9 minutes, 17 seconds until it descended to 15,400 ft msl for about 12 seconds (Figure 1). The data showed that about 2 seconds later, the airplane ascended to 15,575 ft msl, which was followed by a descent to 14,500 ft msl for the last 4 seconds of recorded ADS-B data. The last recorded ADS-B target was located about .46 miles northwest of the accident site.

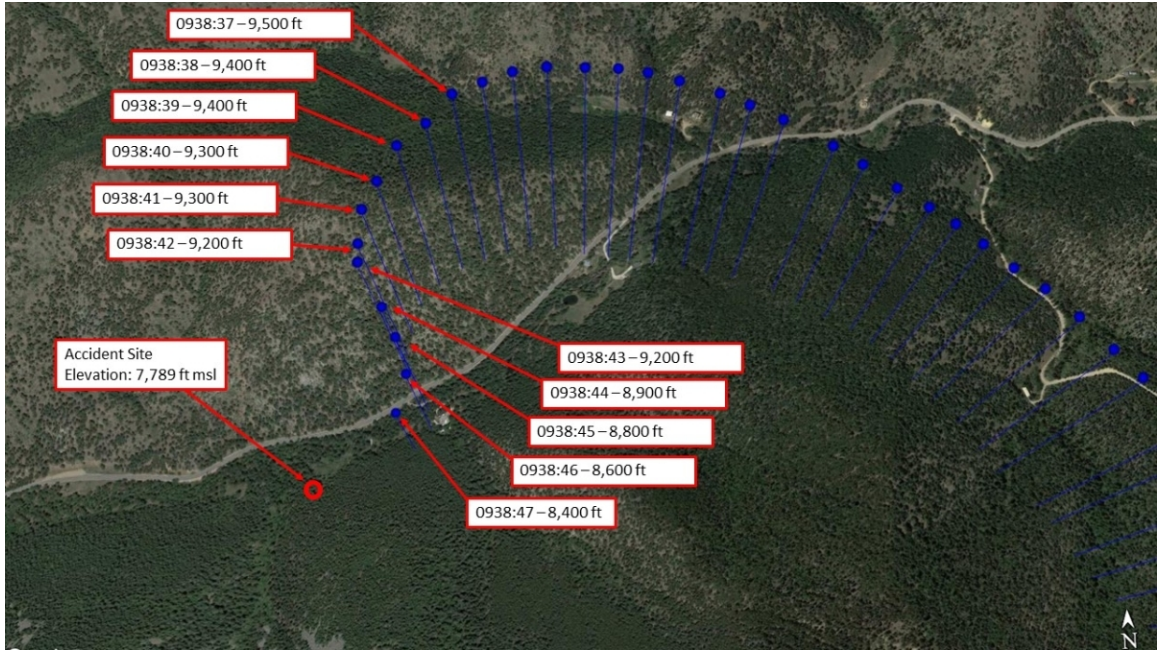
Figure 1: ADS-B Data - Last portion of the accident flight.

As shown in Figure 1, the ADS-B data showed at 0938:37 the airplane had ascended to an altitude of 9,500 ft mean sea level (msl). The tracking then showed the airplane making a descending left turn to an altitude of 8,600 ft msl by 0938:46. The airplane then initiated a right turn. The last recorded ADS-B target at 0938:47 at an altitude of 8,400 ft msl was located about 579 ft northeast of the accident site.

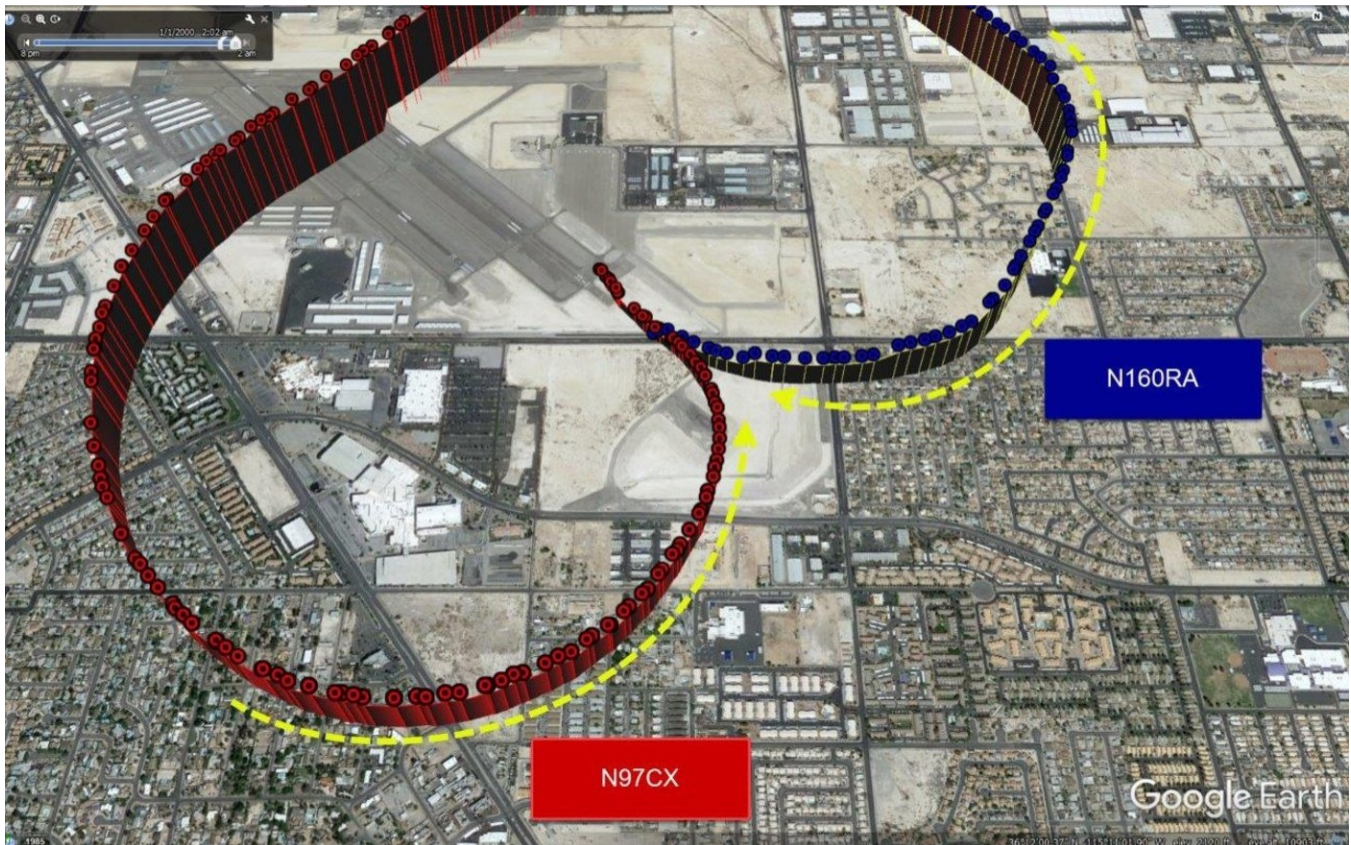
Figure 1. ADS-B Flight Paths for N97CX (PA-46) and N160RA (Cessna 172)

Both airplanes were maneuvering to land at North Las Vegas Airport (VGT), Las Vegas Nevada, when the accident occurred. N97CX had been instructed by air traffic control (ATC) to fly left traffic for runway 30L and N160RA had been instructed to fly right traffic for runway 30R. The airplanes collided about 0.25 nautical miles from the approach end of runway 30R. Figure 1 shows a simplified flight path diagram for the accident flights based on Federal Aviation Administration Automatic Dependent Surveillance – Broadcast (ADS-B) data.

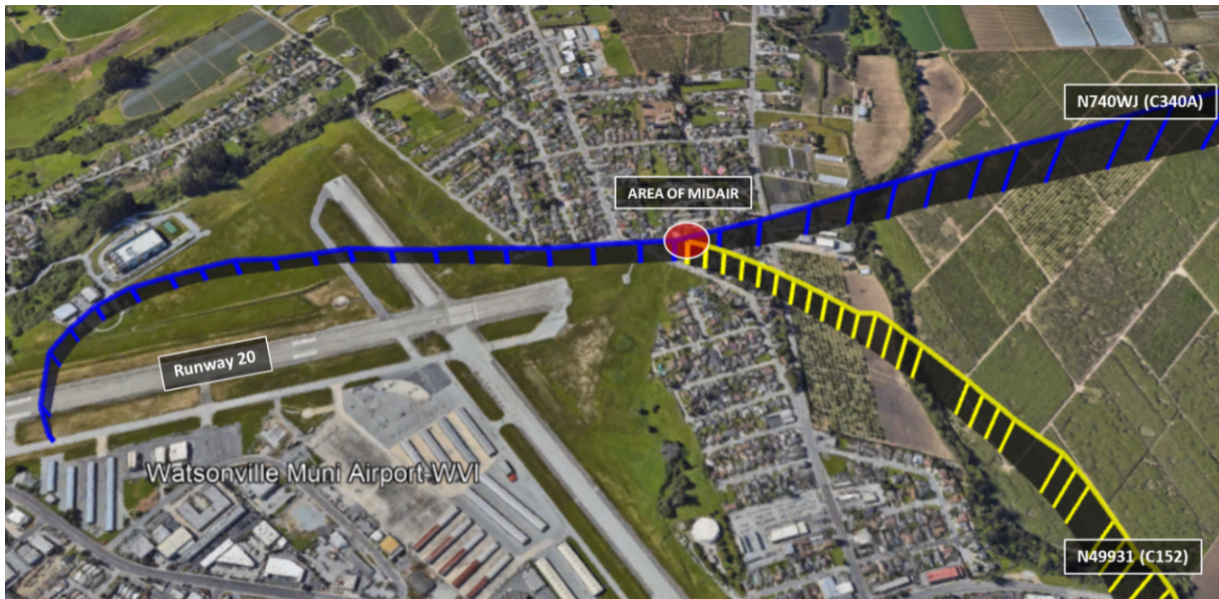
Figure 1. View of the two airplanes' ADS-B flight track data.

According to recorded automatic dependent surveillance-broadcast (ADS-B) data and recorded common traffic advisory frequency (CTAF) communications, the Cessna 152 was in the traffic pattern at Watsonville Municipal Airport (WVI) and had completed four touch-and-go landings. The Cessna 340 was northeast of WVI when the pilot reported that he was 10 miles out and planned to descend for a straight in approach to runway 20. About one minute later, the pilot of the Cessna 152 reported that he was on the crosswind leg, then shortly after reported that he was on the downwind leg for runway 20. The pilot of the Cessna 340 reported that he was 3 miles out and straight in for runway 20. Shortly after, the Cessna 340 pilot reported he was 1 mile out and straight in for the runway. He further stated that he was looking for traffic on left base. The Cessna 152 pilot reported that he did see the Cessna 340 and that it was behind him. The Cessna 152 pilot further stated that he was going to go around, "because you are coming up on me pretty quick."

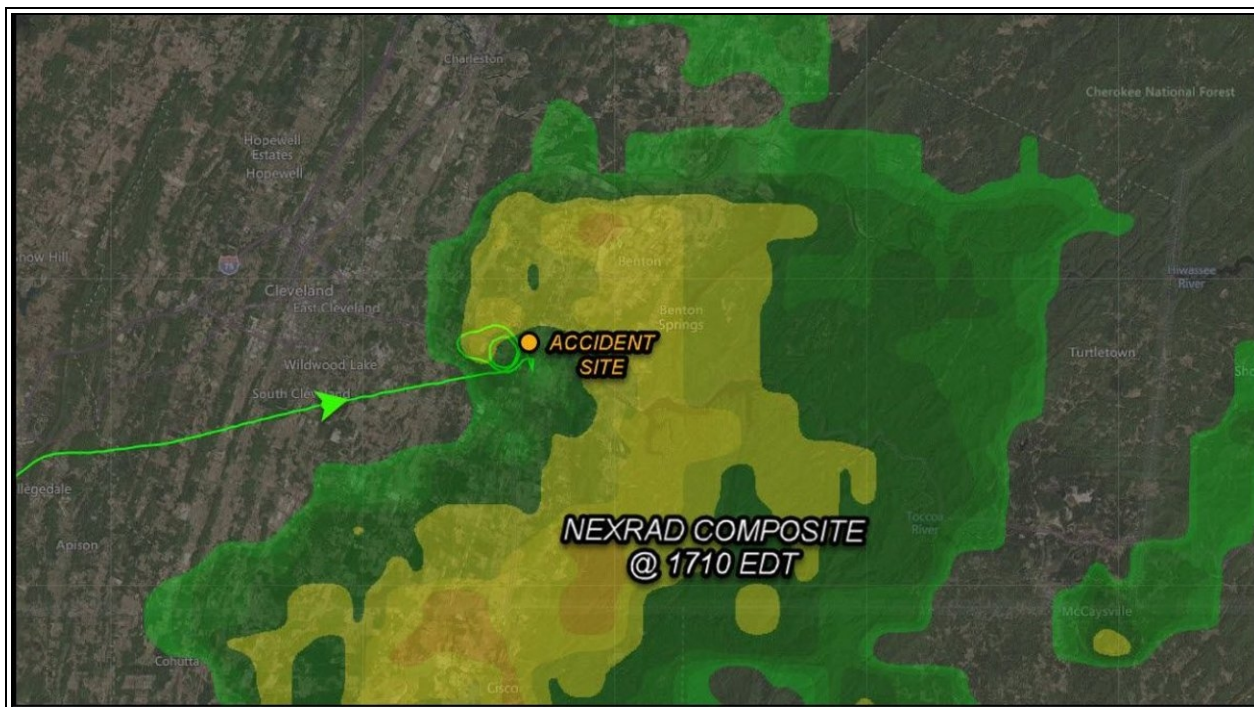
At 1706, the airplane entered a left turn as the flight approached an area of weather. The pilot completed two full 360-degree turns momentarily returning to a northeasterly course. About 1711:10, the airplane entered a right turn from an approximate altitude of 9,075 ft msl. The final data point was recorded at 1711:32 with a corresponding altitude of 7,200 ft msl.

The initial tree impact was located about 0.56 miles northwest of the final data point. Elevation of the accident site was approximately 830 ft, and estimated tree heights were 80 ft above ground level (agl). The debris path was about 480 ft long and oriented on a north-northeast (020°) bearing. The airframe was fragmented. The engine and propeller assemblies were separated and located within the debris path. Both exhibited damage consistent with impact forces.
